## BUILDERS REPORT

### 4 Stormont Place | Kingston

# **House Inspection** **at** 4 Stormont Place Brooklyn

26-May-2025  
Ian Dumbleton

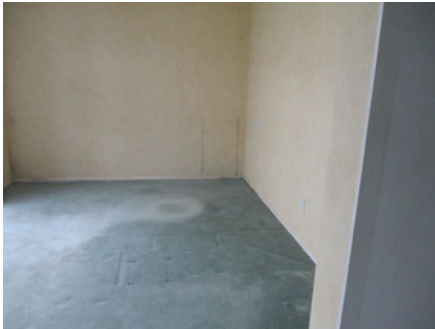
poor - stains to carpet noted and water damage  
average due for repainting  
average due for repainting  
generally good - some trim needs painting  
average due for repainting  
average some windows double glazed  
generally good due for renewal  
average due for decorating  
average

carpets stained in places

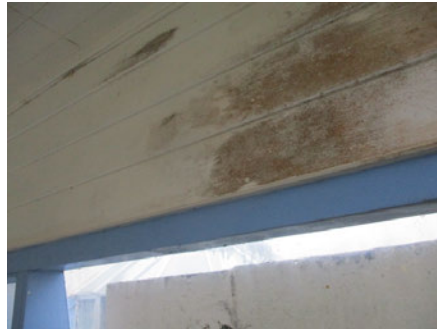
timber due for painting

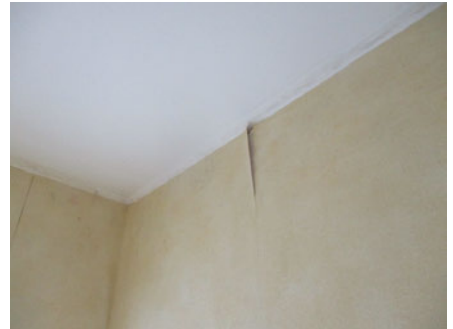
wallpaper peeling in places

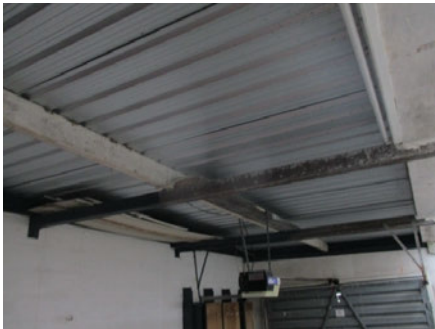
garage door opener not working

<b>GENERAL</b>	TYPE	part of house
	CONDITION	average
	COMMENT	door opener needs repairs
<b>DOOR</b>	TYPE	auto
	CONDITION	tilta door
	COMMENT	needs fixing
<b>POWER SUPPLY</b>	TYPE	yes
	CONDITION	yes
	COMMENT	concrete
<b>LIGHTING</b>	TYPE	generally good
	CONDITION	
<b>FLOOR</b>	TYPE	
	CONDITION

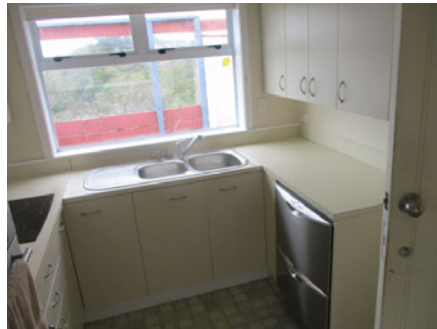
kitchen generally good

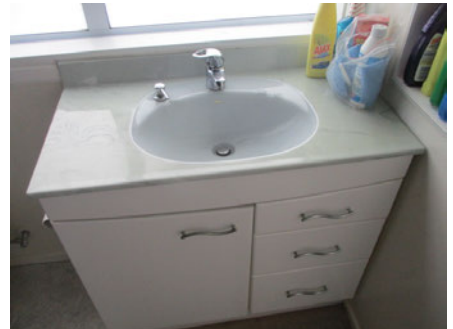
bathrooms generally good

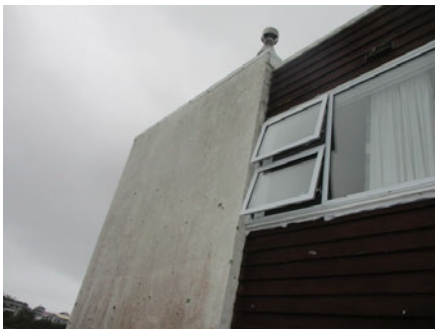
exterior due for painting

<b>WALL STRUCTURE</b>	TYPE	timber framed
	CONDITION	average
	COMMENT	generally in good condition
<b>BASEMENT</b>	TYPE	weather boarded and cement board
	FINISH	paint finish
	CONDITION	average
<b>WALL CLADDING</b>	COMMENT	needs repaint
	TYPE	weatherboard and cement board
	FINISH	paint
	CONDITION	average
	COMMENT	needs repaint

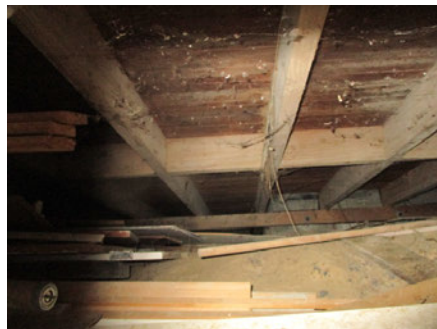
underfloor not insulated in area sighted

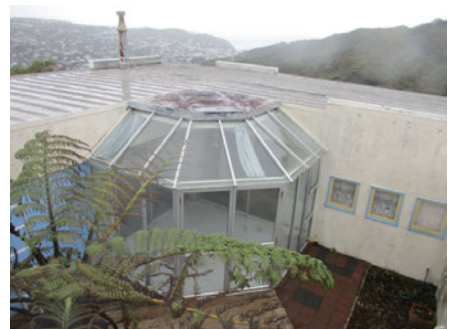
conservatory needs maintenance

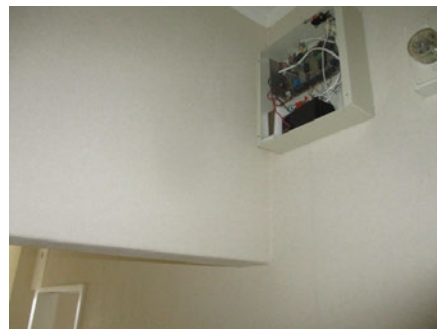
alarm control box - not connected

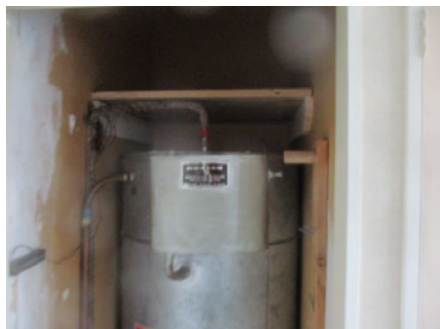
<b>HOT WATER CYLINDER</b>	cylinder should be restrained older type
<b>AGE OF CYLINDER (date on cylinder)</b>	unsighted
<b>CONDITIONS OF PIPES TO CYLINDER</b>	good of what could be seen
<b>TYPE OF HOT WATER SYSTEM</b>	low pressure system
<b>PLUMBING (general condition)</b>	appears good of what could be seen
<b>PLUMBING (type)</b>	various types
<b>CONDITION OF PIPES IN CEILING SPACE</b>	no access to sight
<b>HEADER TANK</b>	mounted on the roof
<b>DRAINAGE IN CEILING</b>	unable to sight
<b>DRAINAGE UNDER FLOOR</b>	unable to sight
<b>GULLEY TRAPS</b>	all appear to be in good condition
<b>GULLEY TRAP LIDS</b>	all appear to be good
<b>FOUL WATER (sewer and waste)</b>	unable to sight
<b>SECTION RUN OFF</b>	appears good
<b>CESSPIT DRAINAGE</b>	not applicable
<b>STORMWATER</b>	all appears to be working well
<b>WATER TANKS</b>	none sighted
<b>DOWNPIPES</b>	all appear to be good
<b>DRIVEWAY OR PAVING SUMP</b>	none sighted

hotwater cylinder

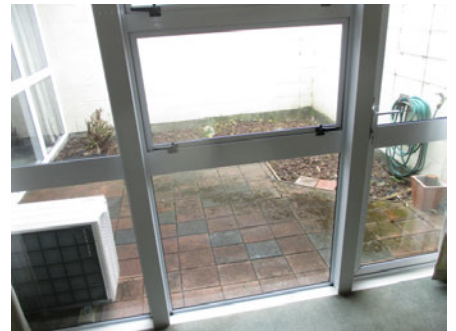
some windows double glazed
