BRIEF REVIEW OF FUSIOTHERM REPORTS - UPDATE

Project: FORTE APARTMENTS, 13 COLLEGE STREET, WELLINGTON

Date: 10 June 2020

Issued by: Michael Stretton Ltd

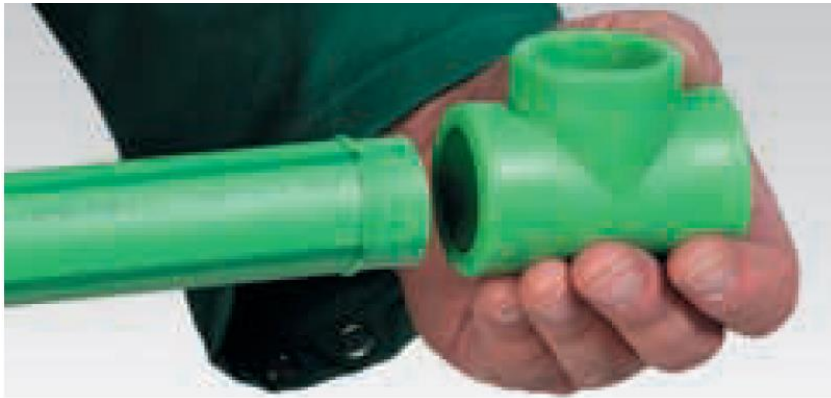
Joining, fixing and...

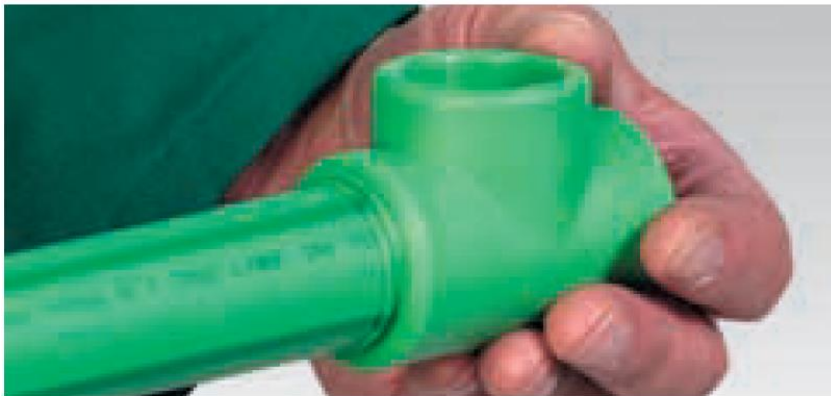
...aligning
