Property Inspection Report

COMPREHENSIVE - VISUAL NON - INVASIVE PROPERTY INSPECTION REPORT

CLIENT:	Ben Petite
ADDRESS:	54 Colson Street Avalon, Lower Hutt, Wellington
AGENT:	Private
INSPECTION DATE & Weather Conditions:	18/8/2025 Cloudy
INSPECTION INSTRUCTIONS	Comprehensive Non -Invasive Property Inspection
EQC STATUS	Unknown

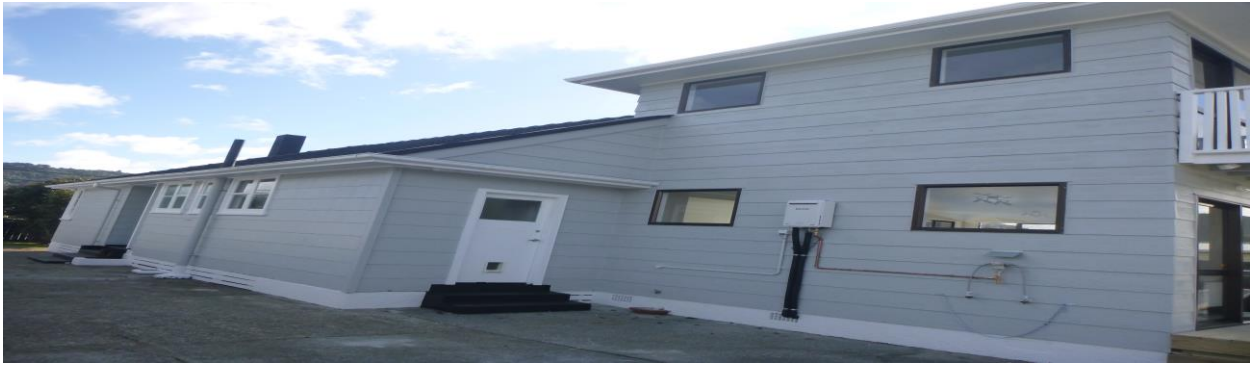
Image 1

South elevation view

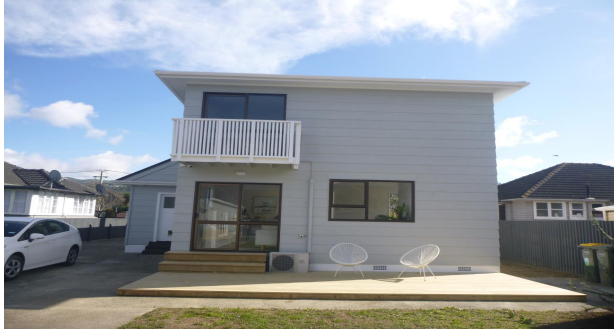
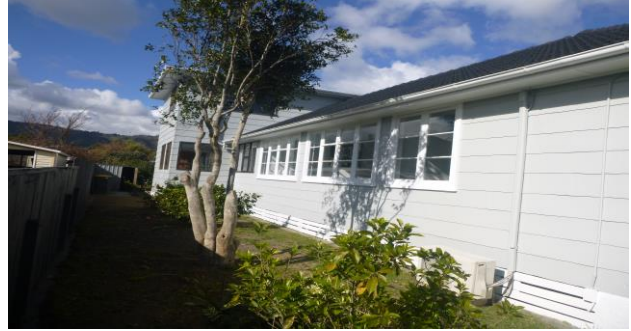
Image 2

East & North elevation view

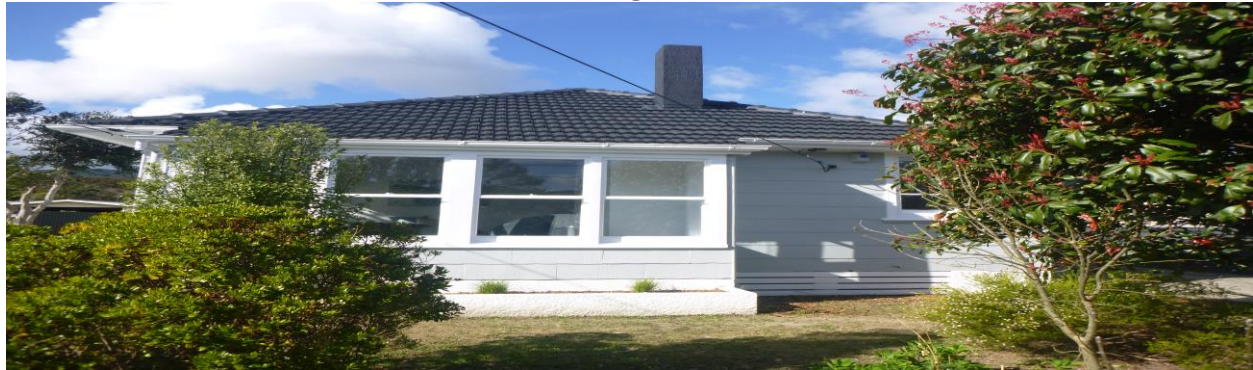
Image 3

East elevation view

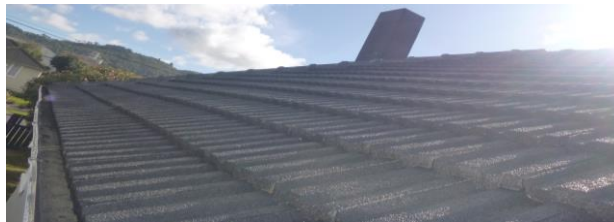
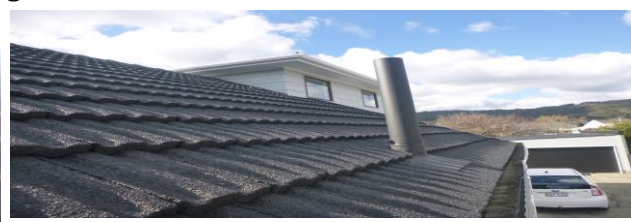
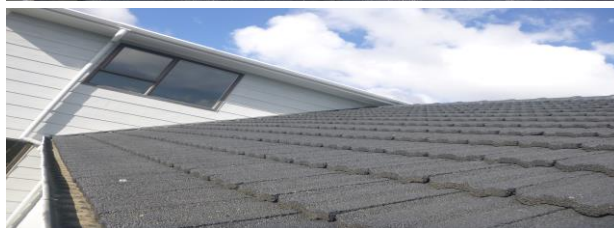
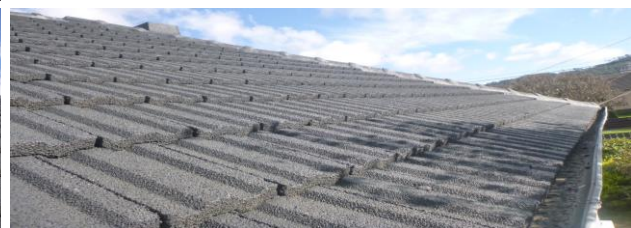
Image 4

ROOFING & STRUCTURE	<p>The hip-type painted concrete tile roof and was in good condition at the time of inspection, the top roof was not inspected due to height restrictions.</p> <p><i>Due to the NZ Health & Safety at Work Act 2015 regarding working alone and at height, only a limited visual inspection of the exterior roofing was conducted from a ladder (3.6m). Any defects or damage in obstructed areas may only be identified once access is provided.</i></p> <p><i>No invasive watertightness or weathertightness tests are conducted, and all comments are based on visual observation only. Due to health and safety reasons, the inspector does not walk on the roof, and observations are made from ladders, scaffolding (if available), or vantage points inside or on the ground.</i></p>	
WINDOWS	The timber-framed single-glazed windows are in good condition. The aluminium-framed single-glazed windows are in average condition; some rubber seal joint gaps require repair, and the filled joints will need ongoing maintenance.

Exterior roof view

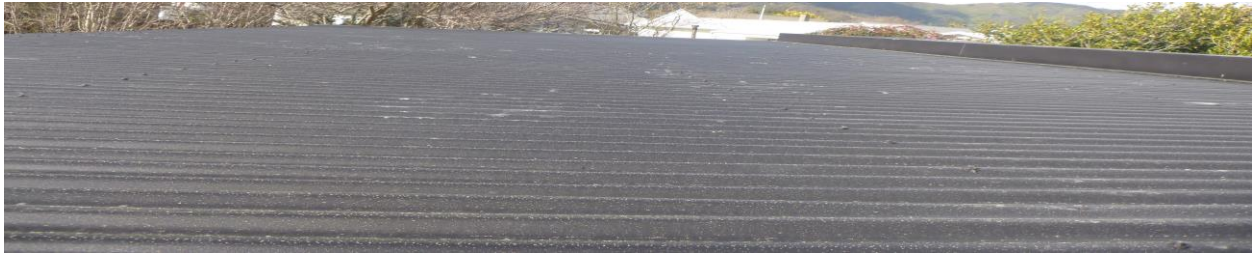
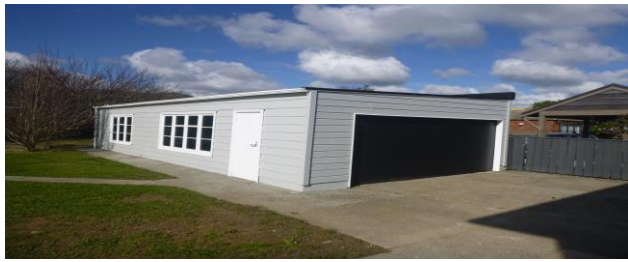
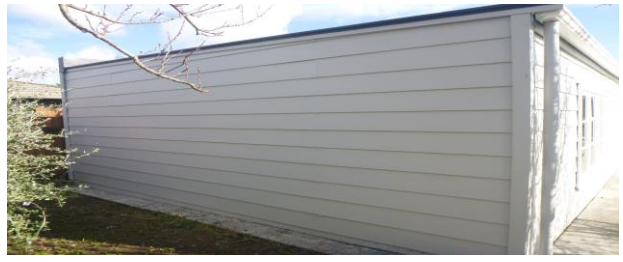
Image 5

The garage roof, exterior cladding, windows, and doors were inspected and in good condition. Both doors were locked at the time, limiting full access.

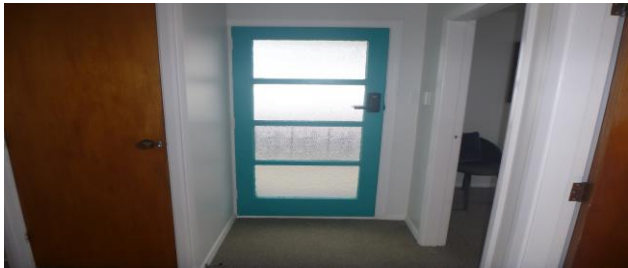
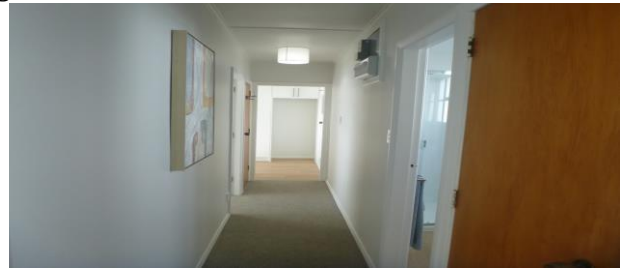
Image 6

Passage doors to rooms

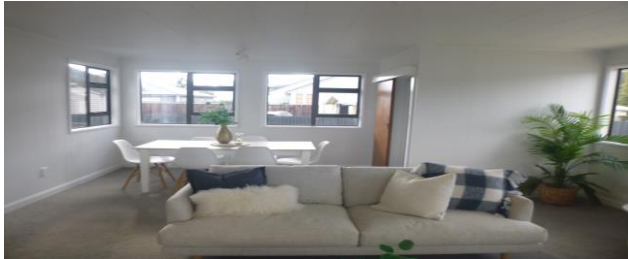
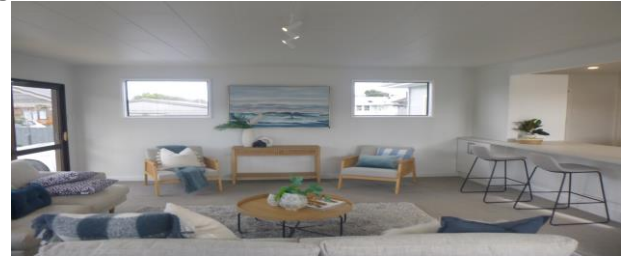
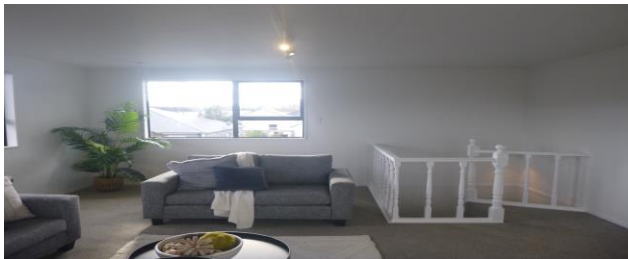
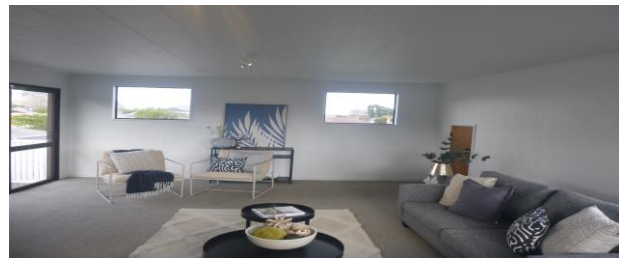
Image 7

LIVING ROOMS		
<i>FLOORING</i>	The carpet flooring in good condition.	
<i>WALLS</i>	The painted board in good condition.	
<i>CEILING</i>	The painted plastered board tile in good condition.

<i>LIGHTING</i>	Operational.	
<i>HEATING</i>	The heat pump in good condition and operational.	
<i>WINDOW REVEALS</i>	Painted and in good condition.	
<i>WINDOW FURNISHINGS</i>	N/A	
<i>TRIMS - ARCHITRAVES</i>	Painted and in good condition.	
<i>OTHER SERVICES</i>		
<i>MOISTURE LEVELS</i>	Tested LOW at the time of inspection.

Living room's view

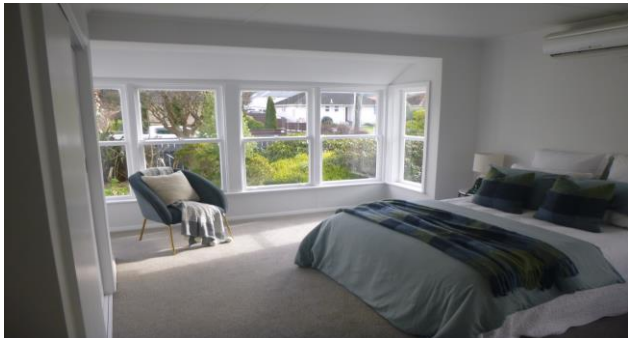
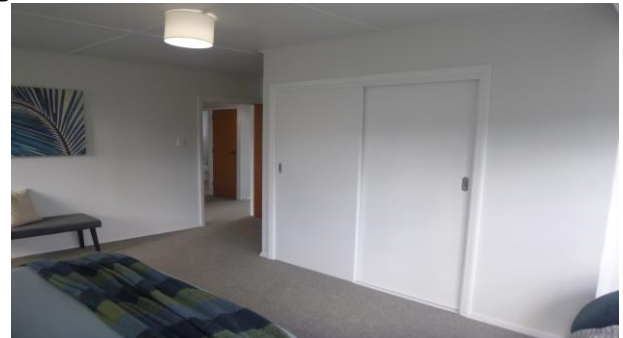
Image 8

BEDROOM 1		
<i>FLOORING</i>	The carpet flooring is in good condition.	
<i>WALLS</i>	The painted plastered board in good condition.	
<i>CEILING</i>	The painted plastered board in good condition.	
<i>LIGHTING</i>	Operational.	
<i>WINDOW REVEALS</i>	All painted and in good condition.	
<i>WINDOW FURNISHINGS</i>	N/A	
<i>DOORS</i>	Internal doors and latches operational.	
<i>WARDROBE</i>	The wardrobe in good condition – doors operational.	
<i>TRIMS - ARCHITRAVES</i>	Painted timber in good condition.	
<i>MOISTURE LEVELS</i>	Tested LOW at the time of inspection.

Bedroom 1 view

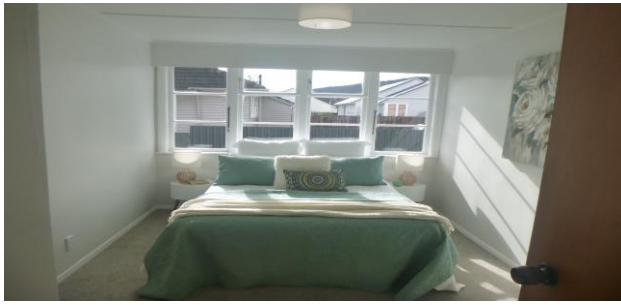
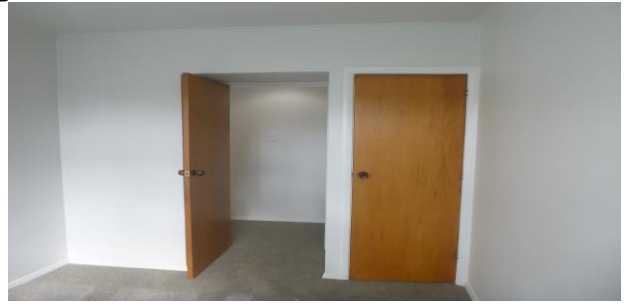
Image 9

BEDROOM 2		
<i>FLOORING</i>	The carpet flooring is in good condition.	
<i>WALLS</i>	The painted plastered board in good condition.	
<i>CEILING</i>	The painted plastered board in good condition.	
<i>LIGHTING</i>	Operational.	
<i>WINDOW REVEALS</i>	All painted and in good condition.	
<i>WINDOW FURNISHINGS</i>	N/A	
<i>DOOR</i>	In good condition and operational.	
<i>WARDROBE</i>	The wardrobe in good condition – door operational.	
<i>TRIMS - ARCHITRAVES</i>	Painted timber in good condition.	
<i>MOISTURE LEVELS</i>	Tested <u>LOW</u> at the time of inspection.

Bedroom 2 view

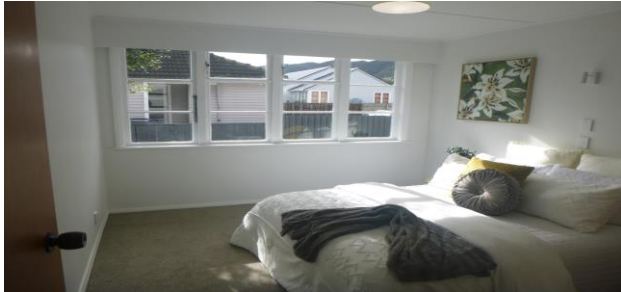
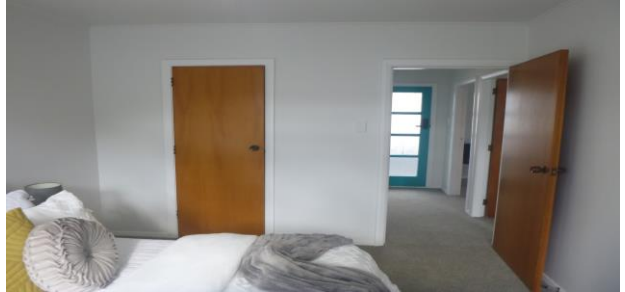
Image 10

BEDROOM 3		
<i>FLOORING</i>	The carpet flooring is in good condition.	
<i>WALLS</i>	The painted plastered board in good condition.	
<i>CEILING</i>	The painted plastered board in good condition.	
<i>LIGHTING</i>	Operational.	
<i>WINDOW REVEALS</i>	All painted and in good condition.	
<i>WINDOW FURNISHINGS</i>	N/A	
<i>DOOR</i>	In good condition and operational.	
<i>WARDROBE</i>	The wardrobe in good condition – door operational.	
<i>TRIMS - ARCHITRAVES</i>	Painted timber in good condition.	
<i>MOISTURE LEVELS</i>	Tested <u>LOW</u> at the time of inspection.

Bedroom 3 view

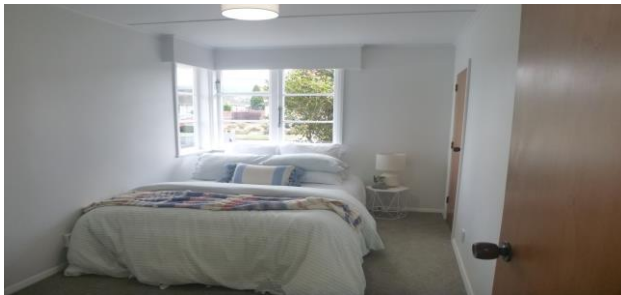
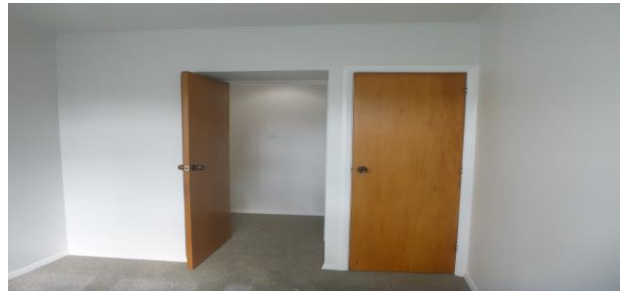
Image 11

BEDROOM 4		
<i>FLOORING</i>	The carpet flooring is in good condition.	
<i>WALLS</i>	The painted plastered board in good condition.	
<i>CEILING</i>	The painted plastered board in good condition.	
<i>LIGHTING</i>	Operational.	
<i>WINDOW REVEALS</i>	All painted and in good condition.	
<i>WINDOW FURNISHINGS</i>	N/A	
<i>DOOR</i>	In good condition and operational.	
<i>WARDROBE</i>	The wardrobe in good condition – door operational.	
<i>TRIMS - ARCHITRAVES</i>	Painted timber in good condition.	
<i>MOISTURE LEVELS</i>	Tested LOW at the time of inspection.

Bedroom 4 view

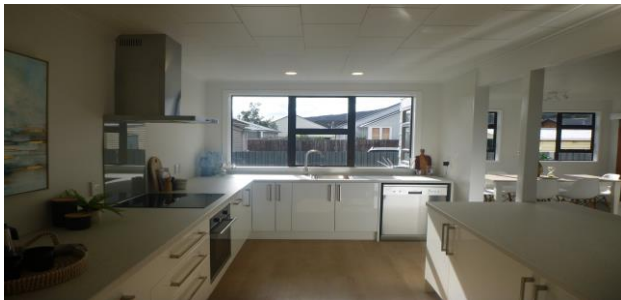
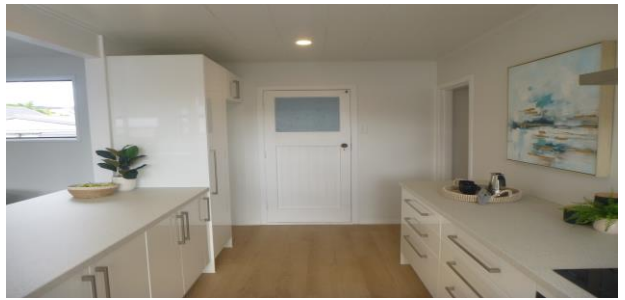
Image 12

KITCHEN		
<i>BENCH TOP</i>	The formica benchtop is in good condition.	
<i>CABINETS</i>	The paint finish and laminate are in good condition.	
<i>SINK & WASTE</i>	The stainless steel insert with PVC waste is in good condition.	
<i>TAPWARE</i>	The tapware is in good condition and operational.	
<i>PANTRY</i>	In good condition.	
<i>OVEN</i>	The oven is in good condition – operational.	
<i>HOB</i>	The top hot plate in good condition and operational.	
<i>RANGE HOOD</i>	In good condition and operational.	
<i>DOOR / WINDOW REVEALS</i>	Painted and in good condition.	
<i>WINDOW FURNISHING</i>	N/A	
<i>FLOORING</i>	The vinyl flooring is in good condition.	
<i>WALLS</i>	The painted board in good condition.	
<i>CEILING</i>	The painted plastered board tile in good condition.	
<i>LIGHTING</i>	Operational.	
<i>OTHERS</i>	Dishwasher in good condition – untested.	
<i>TRIMS - ARCHITRAVES</i>	Painted and in good condition.	
<i>MOISTURE LEVELS</i>	Tested <u>LOW</u> at the time of inspection.

Kitchen view

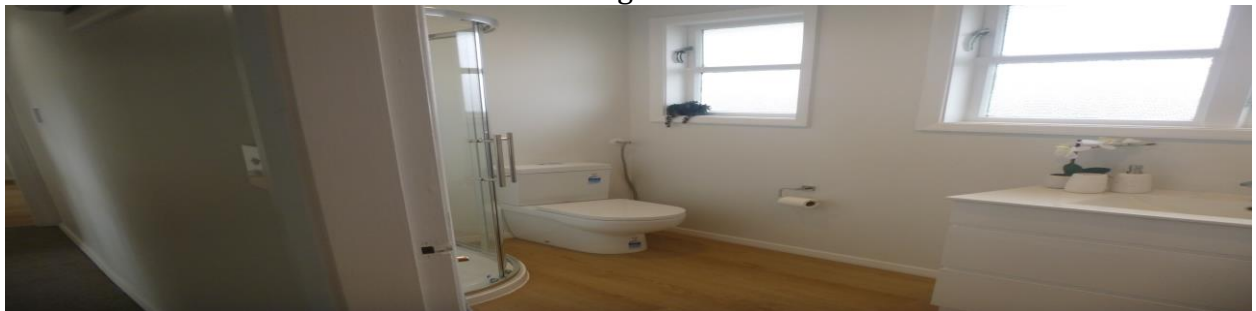
Image 13

BATHROOM		
<i>PAN & CISTERN</i>	Dual flush systems operational.	
<i>SHOWER</i>	Wet wall lining and fiberglass base in good condition.	
<i>BATHTUB</i>	N/A	
<i>VANITY</i>	In good condition.	
<i>EXTRACTOR</i>	In good condition and operational.	
<i>PLUMBING FITTINGS</i>	In good condition.	
<i>FLOORING</i>	The vinyl flooring is in good condition.	
<i>WALLS</i>	The painted plastered board in good condition.	
<i>CEILING</i>	The painted plastered board in good condition.	
<i>TILING</i>	N/A

Bathroom unit view

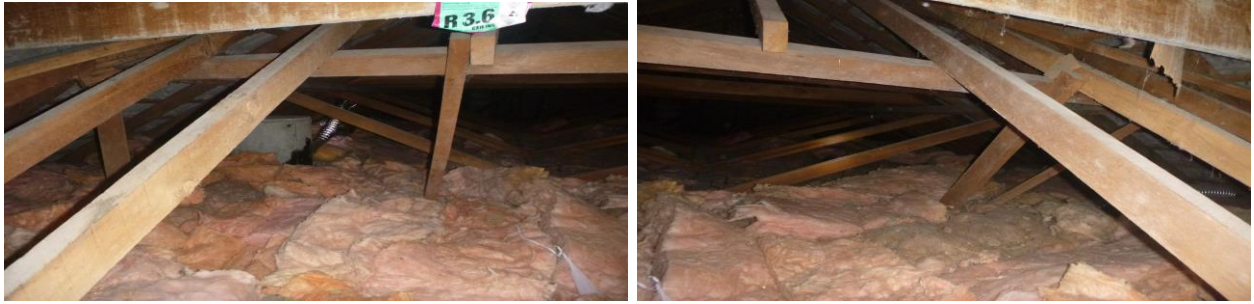
Image 14

<i>CEILING INSULATION</i>	The fiberglass batt insulation in good condition.	
<i>FLOORS INSULATION</i>	The polyester insulation in good condition.	
<i>ROOF STRUCTURE</i>	The timber frame roof is in good condition. <i>The roof space inspection was limited and could not be fully completed. A visual inspection was conducted from the inspection hatch, and only areas visible from this vantage point were observed and included in this report. Access restrictions were due to the presence of insulation.</i>	
<i>MOISTURE LEVELS</i>	Moisture readings taken throughout the house indicated LOW (DRY) levels at the time of inspection, with no signs of elevated moisture level reading detected.	
<i>MOISTURE TESTS</i>	<p>Multiple moisture readings were taken in each room to provide an overall indication of the moisture levels within the house. It is important to note, however, that this does not guarantee the absence of areas with elevated moisture levels.</p> <p>While every effort is made to detect moisture issues, inspecting every square metre of interior wall space during the inspection is not feasible.</p> <p>The readings were obtained using a T660 moisture tester.</p> <p>Measurement Scanning Depth: up to 40mm</p> <p>Less than 40 digits = Dry</p> <p>40-80 digits = Damp</p> <p>Over 80 digits = Wet</p>

Interior roof space view

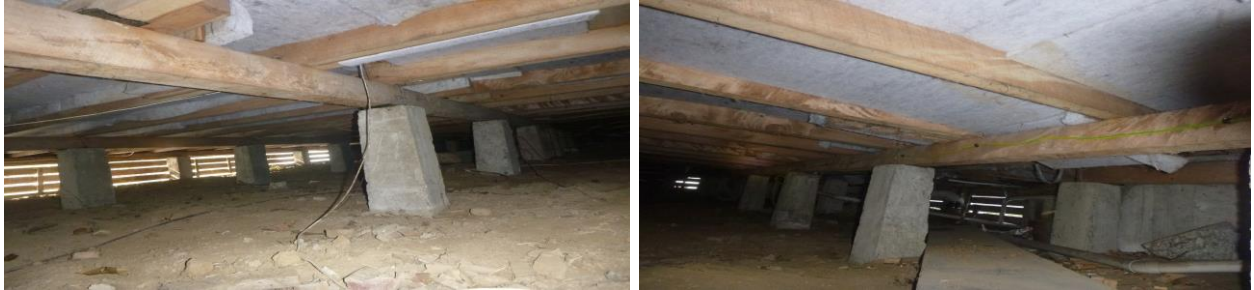
Image 15

EXTERIOR		
FOUNDATIONS	<p>The concrete perimeter walls and concrete pile foundations were observed to be in good condition and are connected to the suspended timber subfloor. The visible plumbing pipes also appear to be in good condition.</p> <p><i>The floor foundation could not be fully inspected due to the presence of floor insulation, and limited access in certain areas.</i></p>	
CLADDING	<p>The painted fiber cement boards are in good condition; however, the joint gaps require ongoing maintenance.</p> <p><i>No watertightness or weathertightness tests are carried out during visual, non-invasive inspections of this kind so all comments regarding these issues are based on observation only.</i></p>	
SOFFITS	The painted board is in good condition.	
GABLE BOARD	In good condition.	
PAINTING	In good condition.	
FASCIA	The fascia board is straight and in good condition.	
GUTTERING	PVC spouting in good condition.

Interior subfloor view

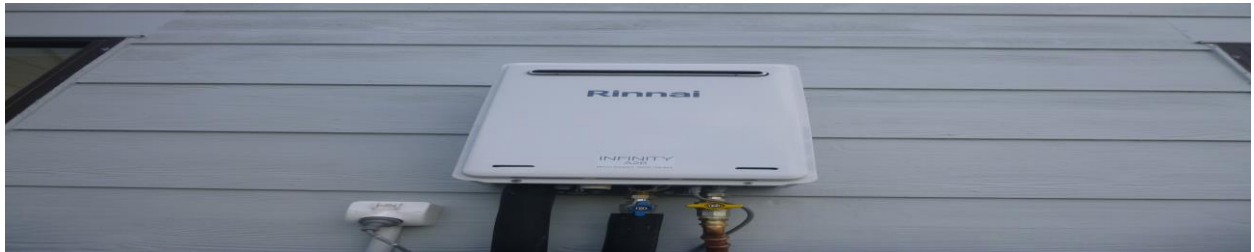
Image 16

The continuous hot water system in good condition but not operational at the time of inspection

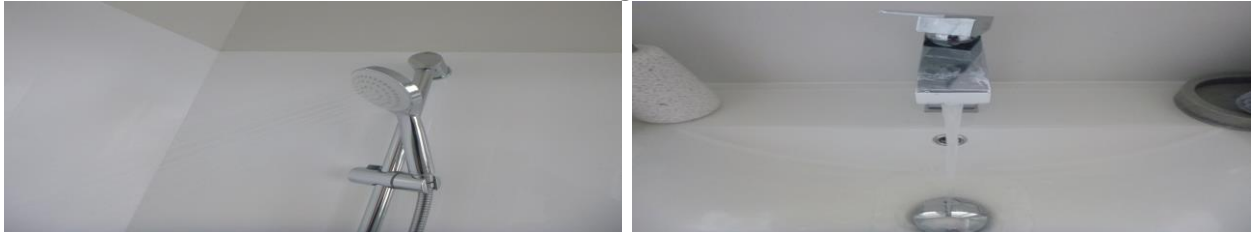
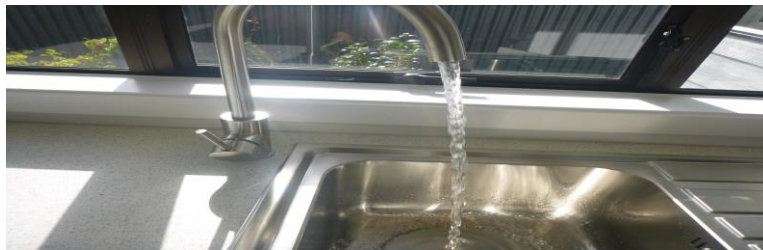
Image 17

The water pressure is in good condition.

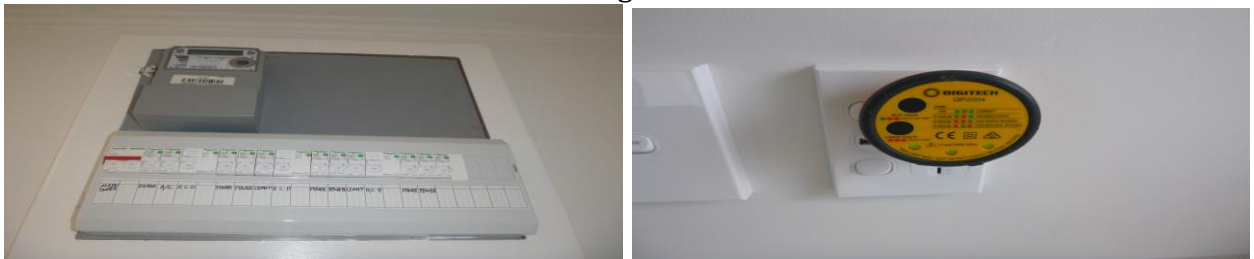
Image 18

The electrical distribution board and circuit breakers are in good condition

Power point check view

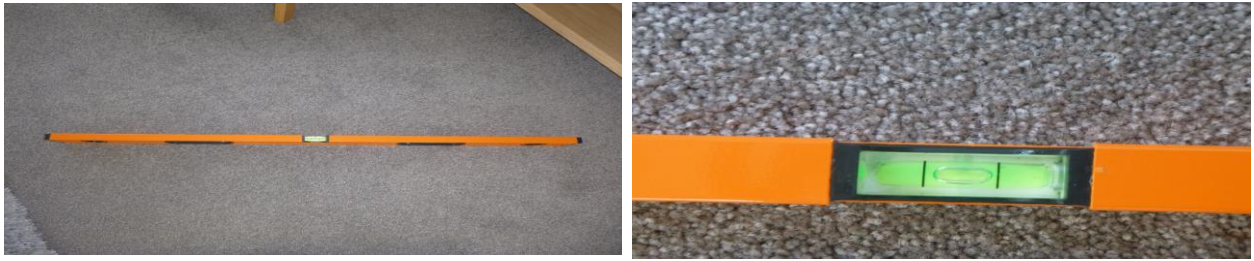
Image 19

The floor level showed an approximate 20 mm variation, which is within MBIE's acceptable tolerance—up to 20 mm for new homes and 50 mm for existing or altered dwellings. The floor slope was also within the allowable limit, measuring less than 0.5% over a one-metre check.

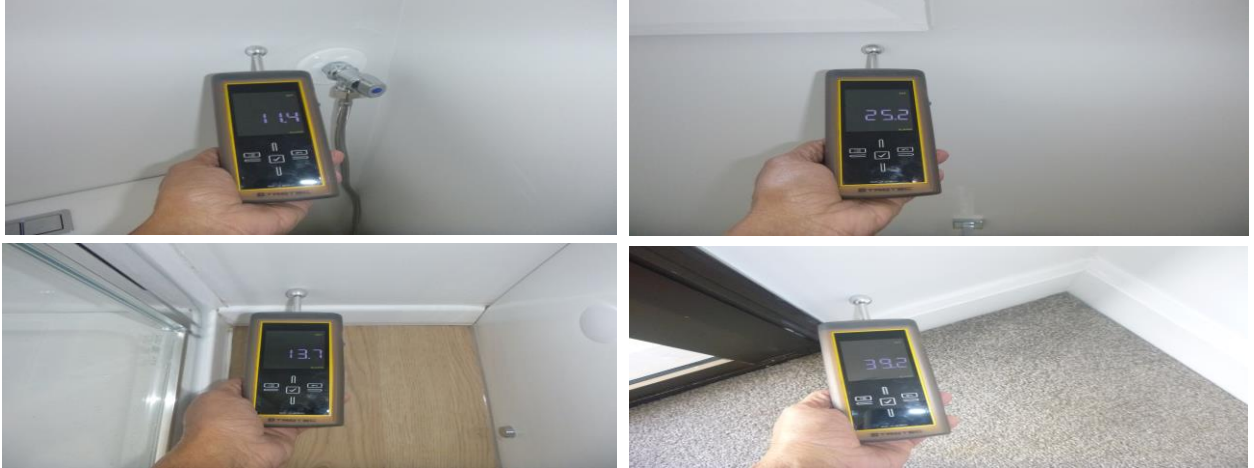
Image 20

The moisture level check revealed no significant concerns or indications of elevated moisture during the inspection
