Independent Builders Report

THIS Southern Manawatu Ltd

Tue 16 Mar 2021

6 Swadel Way, Karori, Wellington, 6012, New Zealand

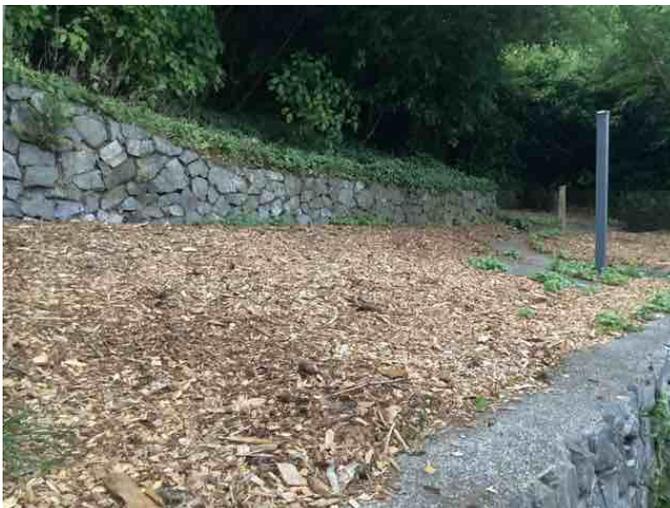
The rear section is tidy and in reasonable condition.

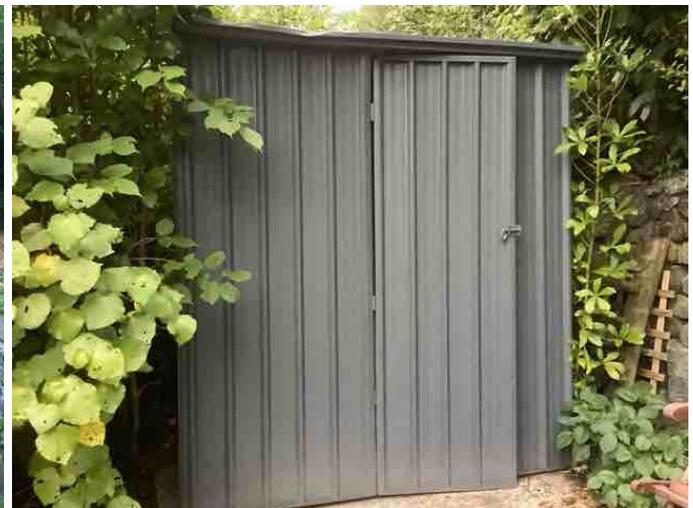
The front of the shed has been painted but the rest of it is showing signs of age.

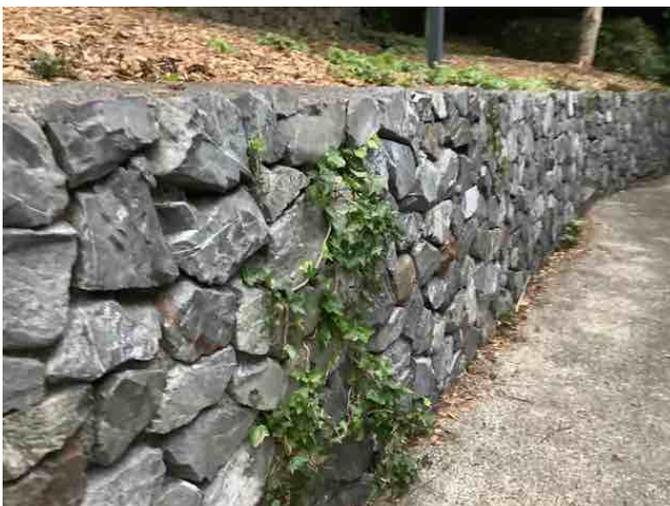
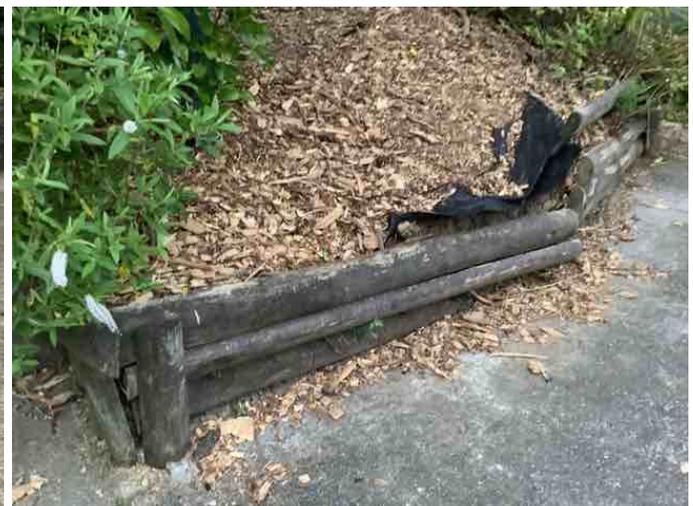
No significant stresses or concerns with the stone retaining walls.

The damaged retaining wall at the front of the home will not impact the property. It can be removed or re built very easily.

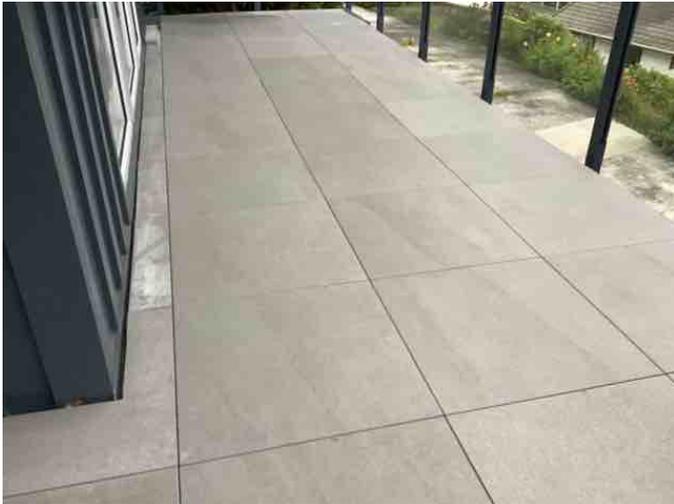
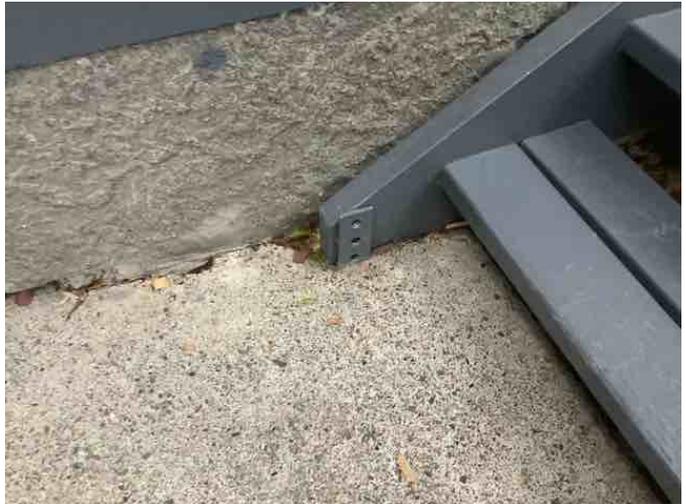
The recently installed tiles over the front decked area are in good order. The decks recent improvements have been completed to a good standard.

Minor detail but recommend installing the missing fixings from the stairs to the front decked area.

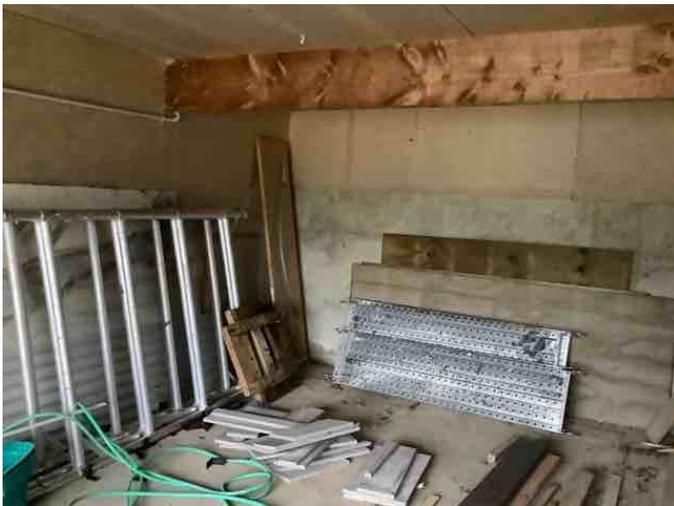
No issues where able to view in the garage area.

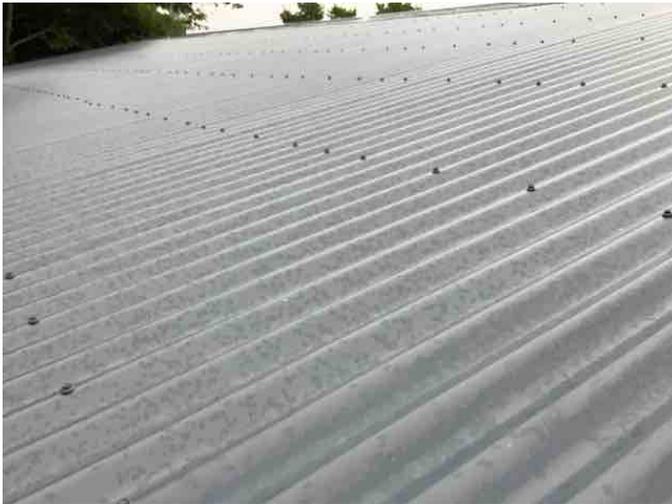
The roof wasn't accessed due to the moisture present after the recent rain. It was viewed by ladder at the rear and front. It has been fully replaced in recent years and although appearing to be in good order, minor improvements are needed.

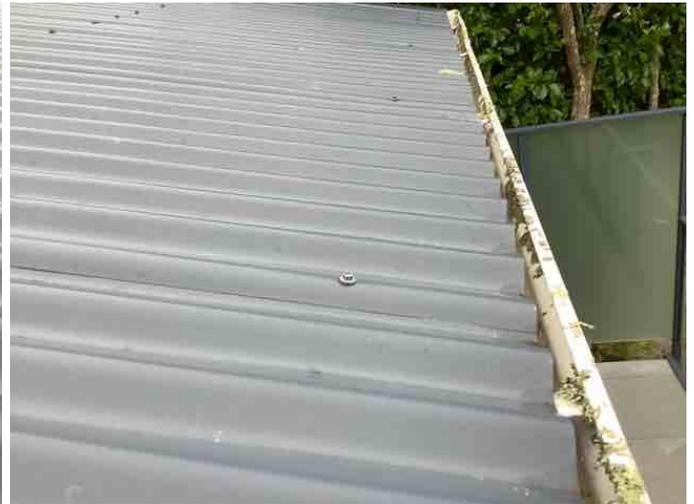
Screws should be installed on every second corrugation on the top and bottom rows. This is not the case with additional fixings needed.

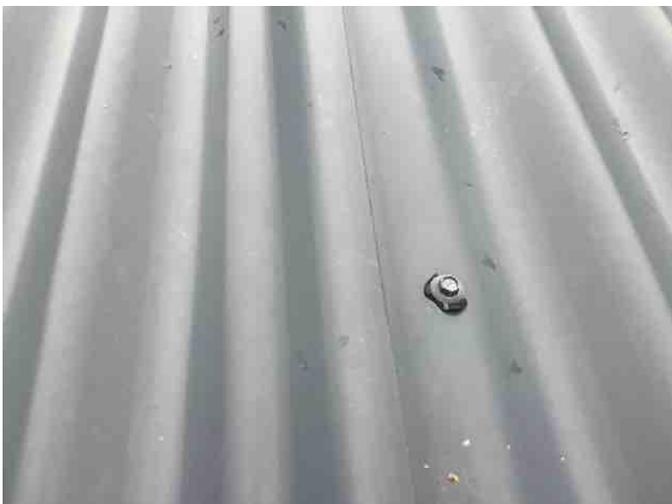
Some of the fixings have been over tightened. This is clear to see where the washer is visible outside the screw head. Loosening the screw may improve but some washers may need to be replaced.

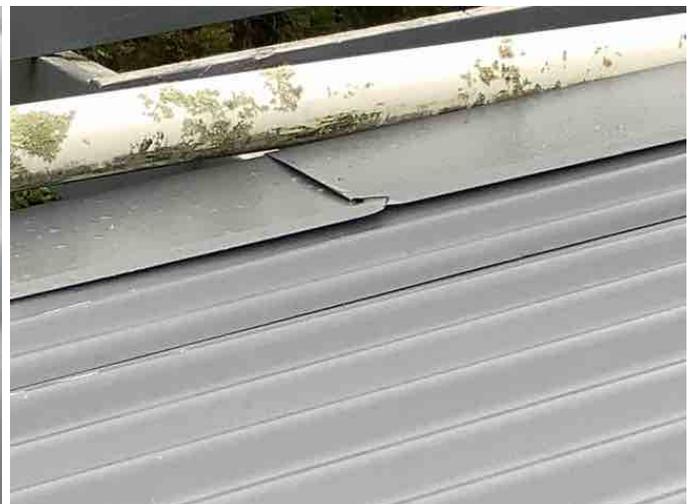
All flashings should be sealed and secured together with improvements needed where these aren't present.

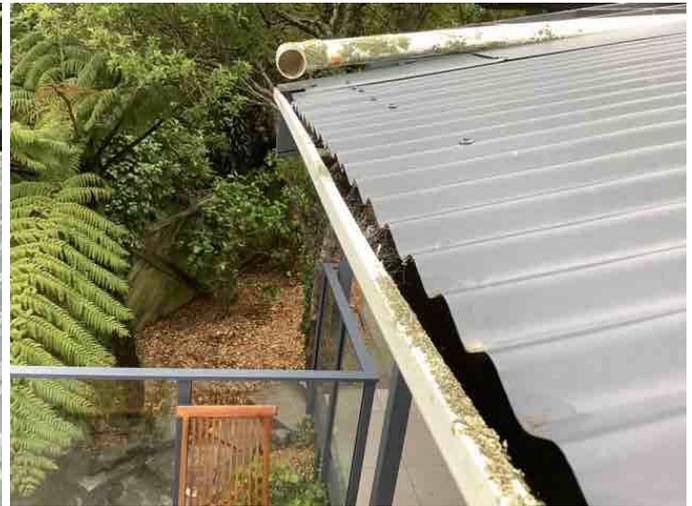
The iron on the front and rear of the home should be cut back to around 50mm past the fascia board. Water may run over the gutter in extreme weather conditions because it is too long.

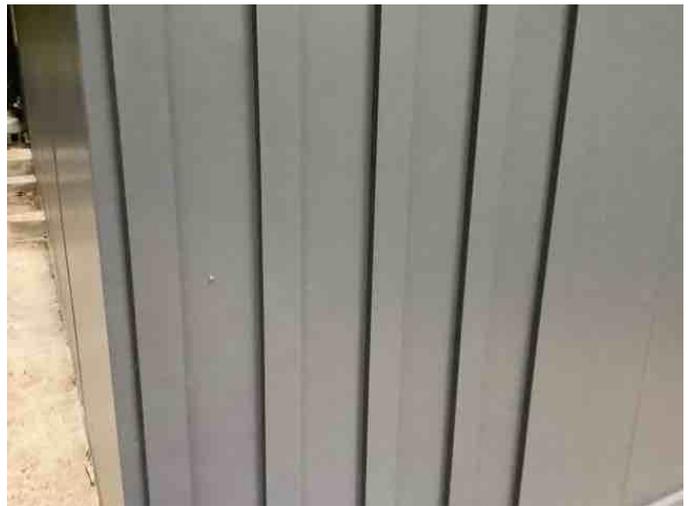
The board and batten clad areas appear to be in similar condition with no concerns sighted.

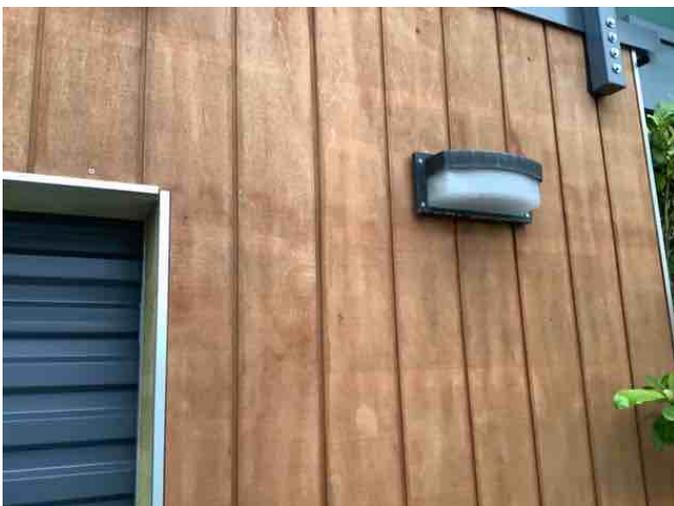
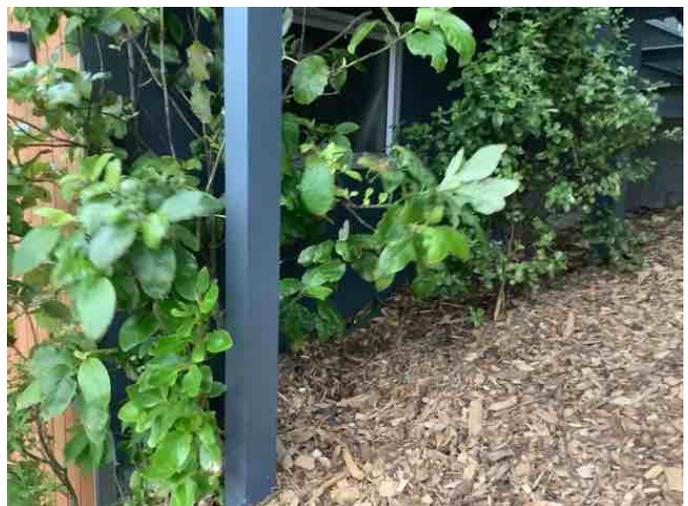
The front face of the garage has been re-clad in shadow clad or similar treated plywood type product. This requires additional fixings to be installed to make sure it is adequately secured to the framing behind. 150mm centres are recommended on it's perimeter and 300mm centres on the studs.

Recommend lowering the gardens on the two sides of the garage to prevent potential moisture damage to areas behind.

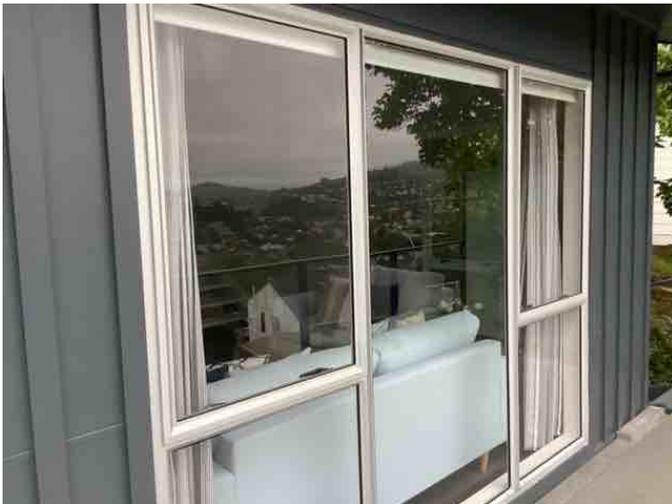
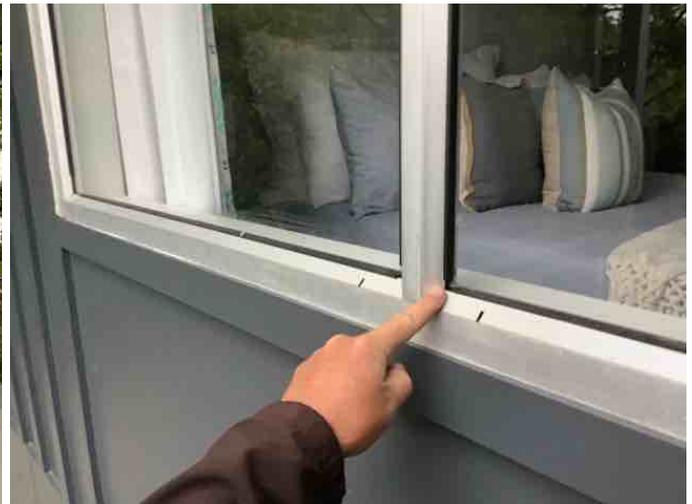
The homes windows and doors appear to be well sealed to each of the cladding types. Recommend maintaining the junctions between the aluminium and cladding to prevent potential weather tightness issues.

Getting the homes joinery services recommended to be a part of ongoing maintenance. This will address areas where the rubber window seals have shrunk and can improve how some of them function.

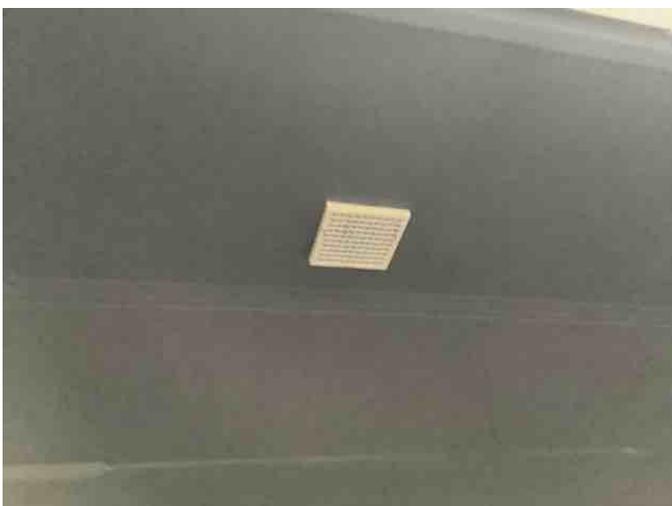
The homes extractors vent externally.

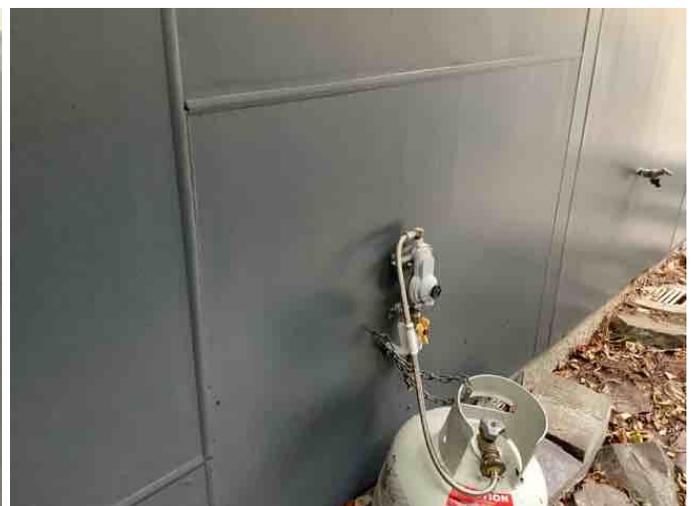
Two sheets of cement board at the rear of the home appear to have been replaced in recent times. They have horizontal jointers present. These need to be kept well sealed to prevent potential most issues.

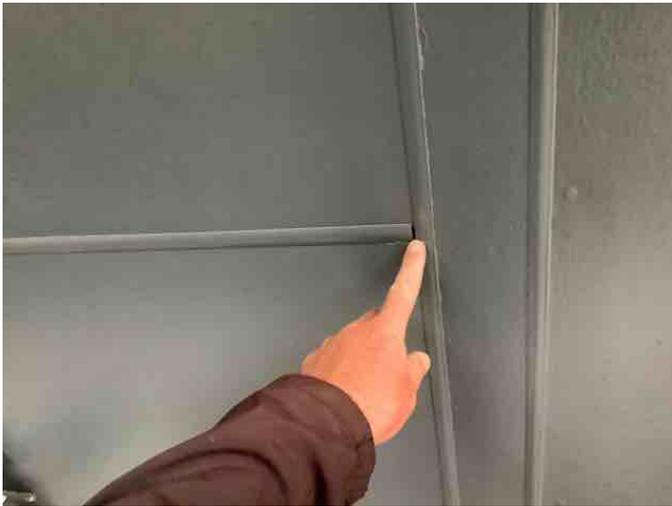
Minor sealant improvements recommended on the ends of the horizontal jointers where the boards have been replaced to prevent potential moisture concerns. 1/4

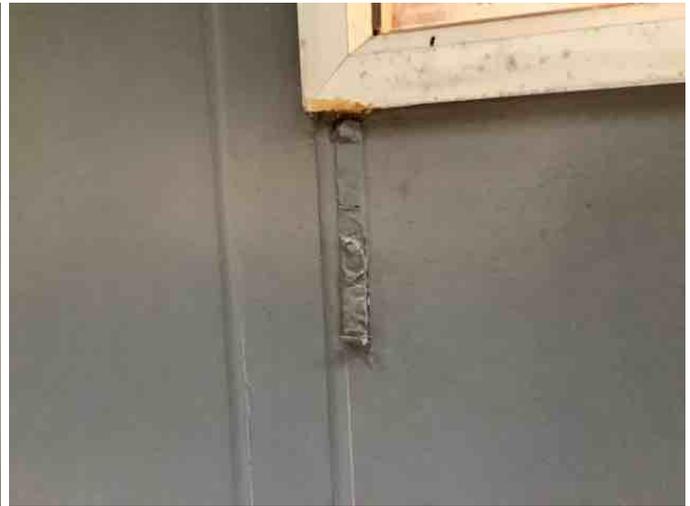
A small redundant bracket is present on the rear right of the home which isn't causing concern but should be replaced before the holes are filled and sealed.

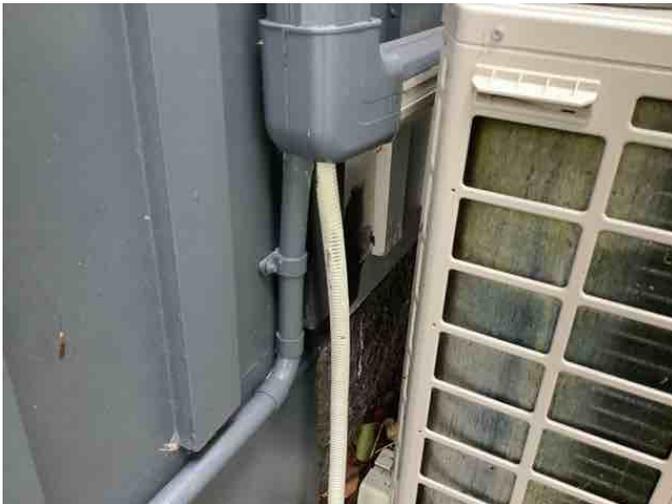
Recommend painting the cladding in behind the heat pump. 1/4

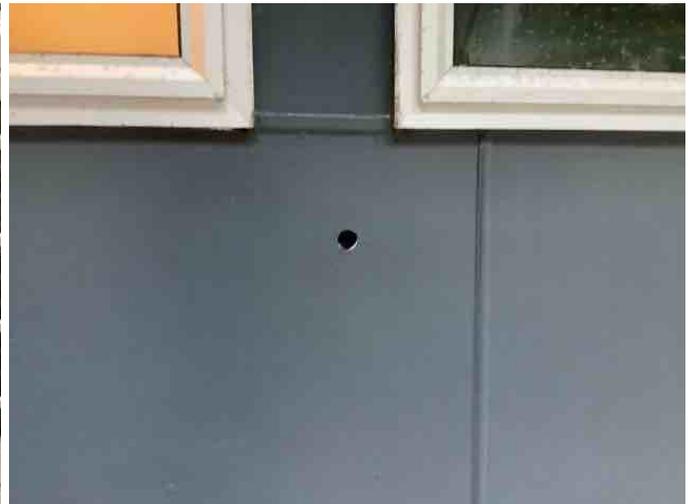
The old toilet overflow hole at the rear of the home is no longer needed and it can be filled and sealed or patched over. 1/4

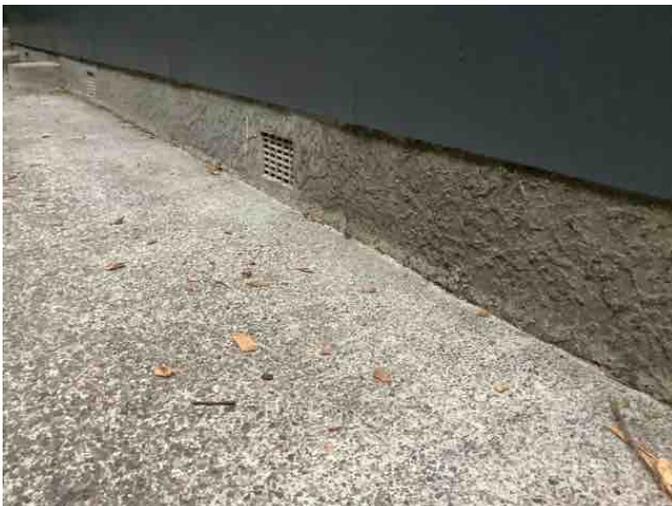
No significant stresses or concerns sighted with the homes concrete ring foundation

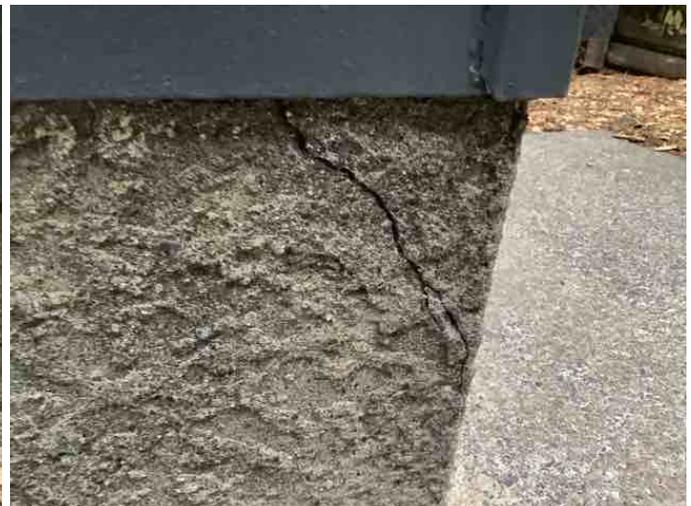
There is a small crack on the concrete on the rear left corner of the home but this is of no concern.

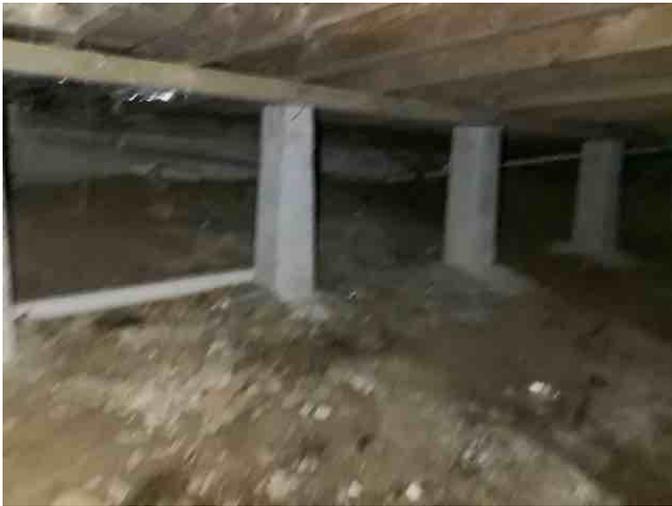
Good ground clearance is present below the framing for ventilation with no structural concerns sighted.

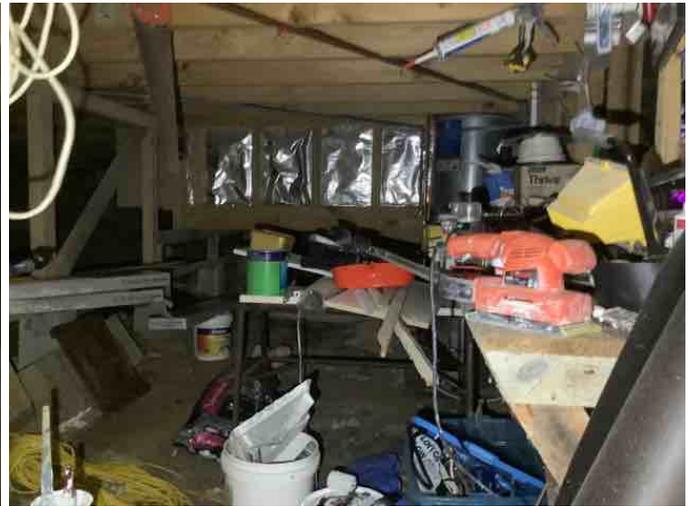
Recommend having a clearer assessment of the front sub floor area once the personal belongings are removed. No concerns where able to view.

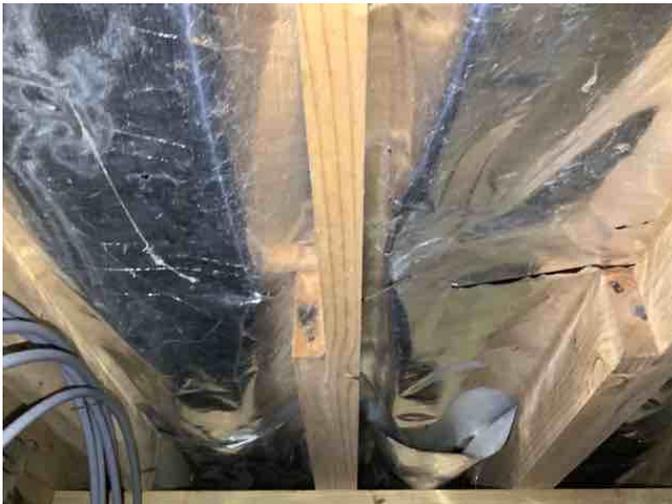
The reflective foil in the homes sub floor area is called sisilation. It was common to be installed at the time of construction but it holds no thermal properties. It will need to be removed before any insulation is installed. The advice of professionals is recommended as the power needs to be disconnected before it is removed to prevent a potential hazard occurring.

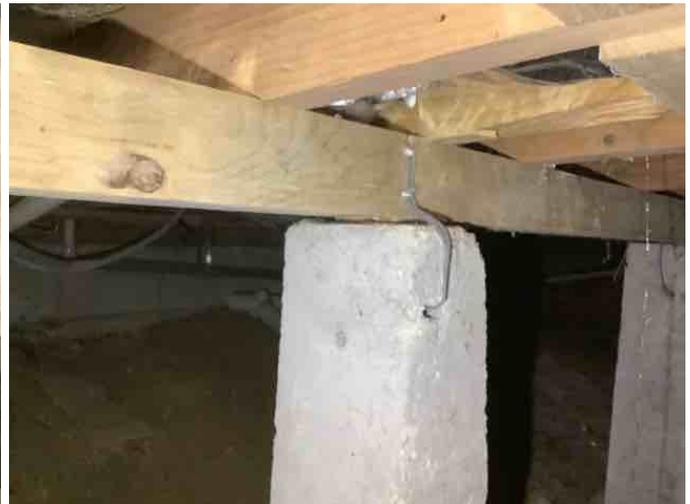
No structural concerns sighted with the homes internal piles. Good pile to bearer connections present.

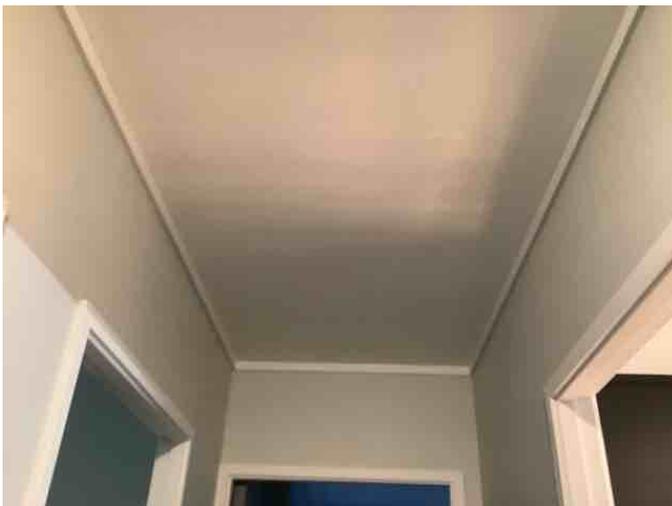
It is recommended to have smoke alarms installed within 3 m of all bedrooms. Recommend putting one in the hall outside. $\frac{1}{4}$

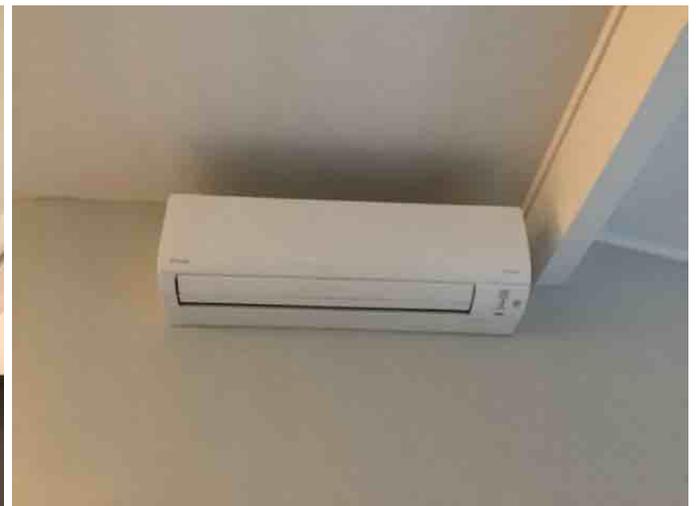
Heat pumps require regular servicing to be efficient. Recommend getting details service requirements from the manufacturer.

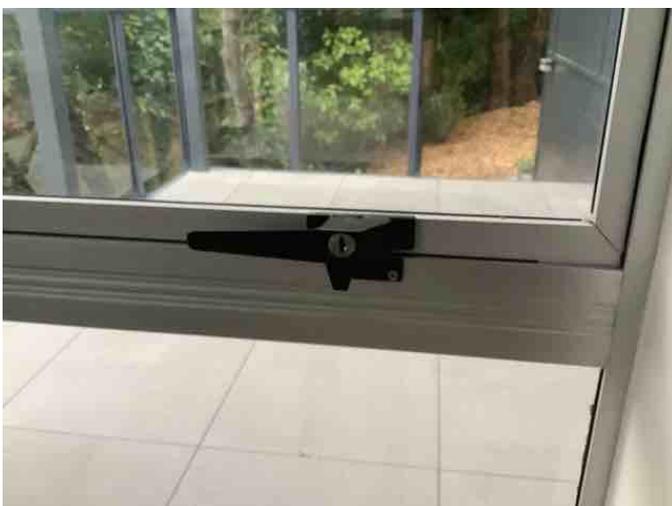
Security stays noted to some windows.

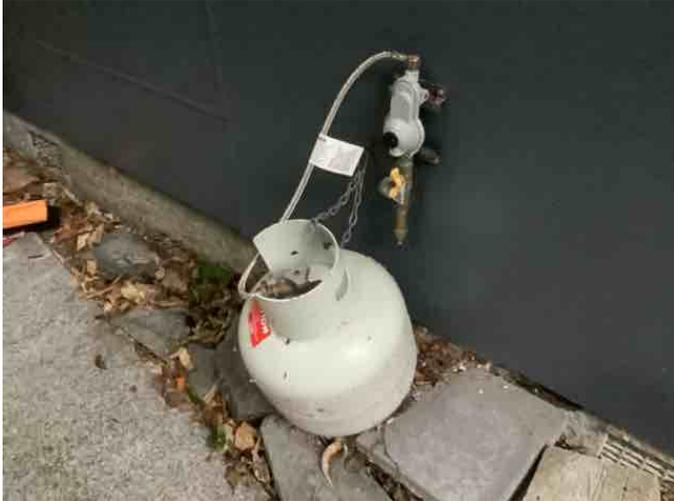
Recommend installing a flat surface below the gas bottle at the rear.

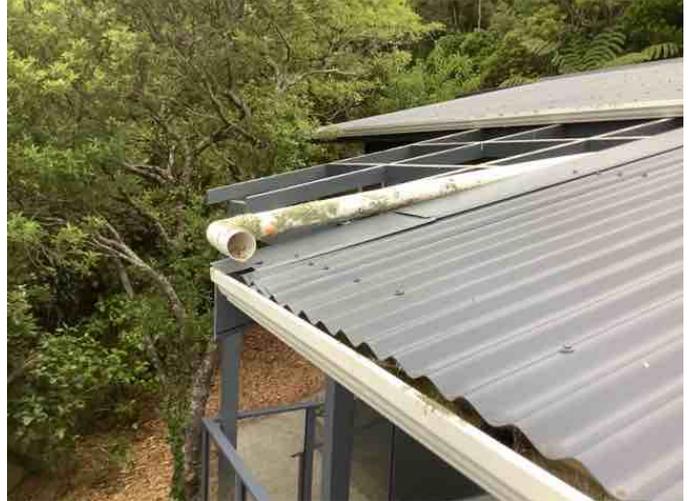
The front downpipe terminates into the lower gutter. This may overflow in extreme weather conditions but can be improved reasonably easily if this is the case.

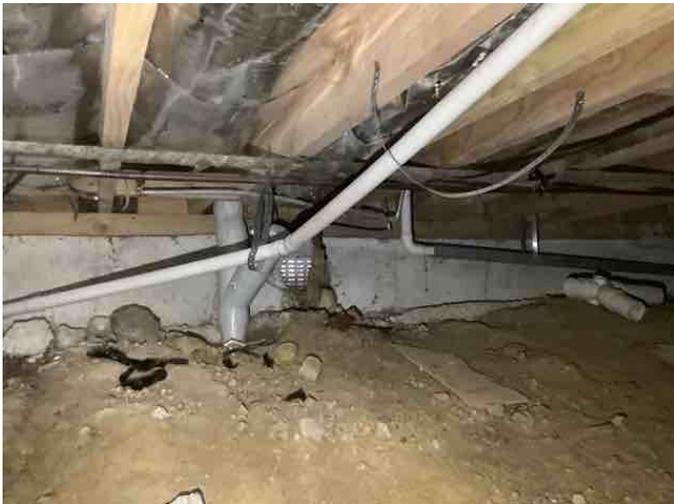
No visible concerns with the plumbing pipes in the sub floor area.

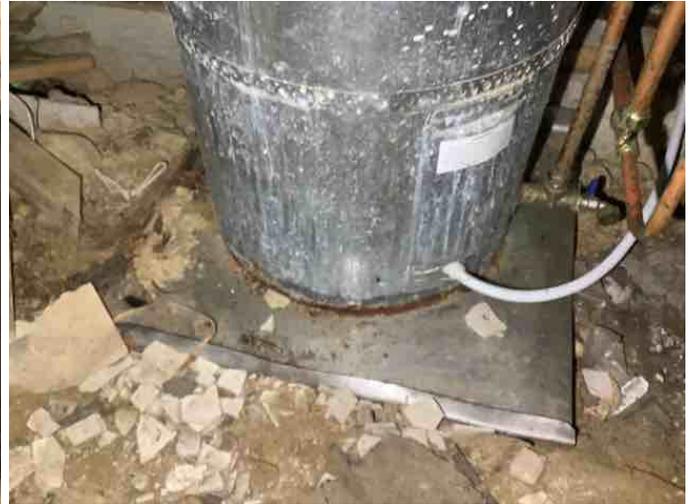
With corrosion present around the base of the cylinder, this may need to be replaced. No water is present to indicate current concerns but it should be monitored or checked by a plumber.

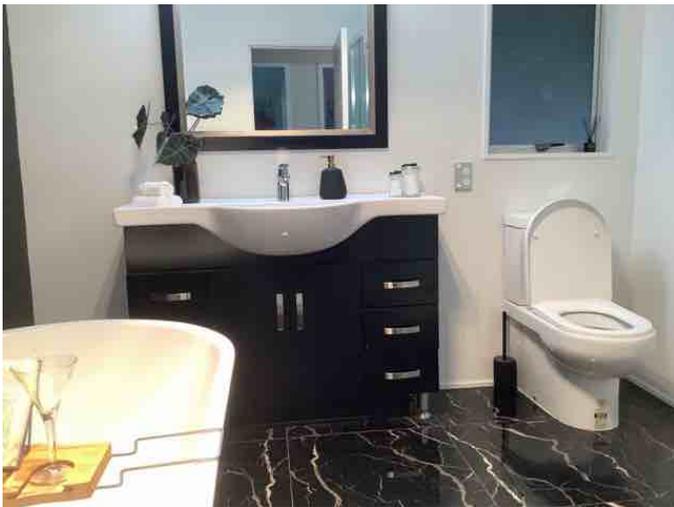
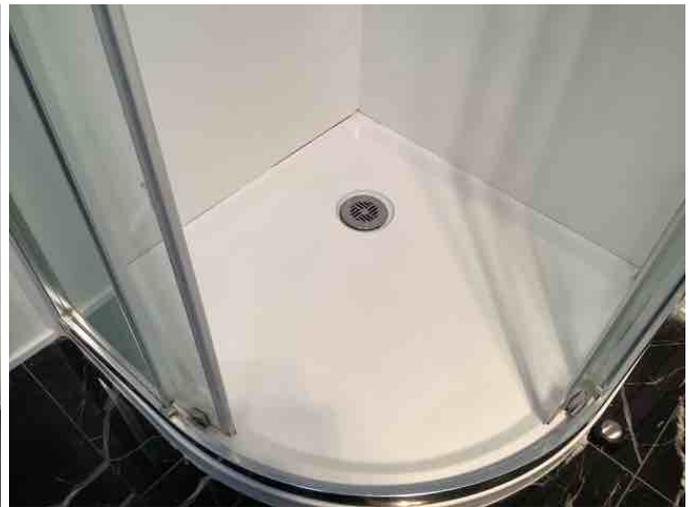
No visible concerns in the shower enclosure. Moisture scanned common fail areas outside the shower enclosure with no elevated moisture readings detected.

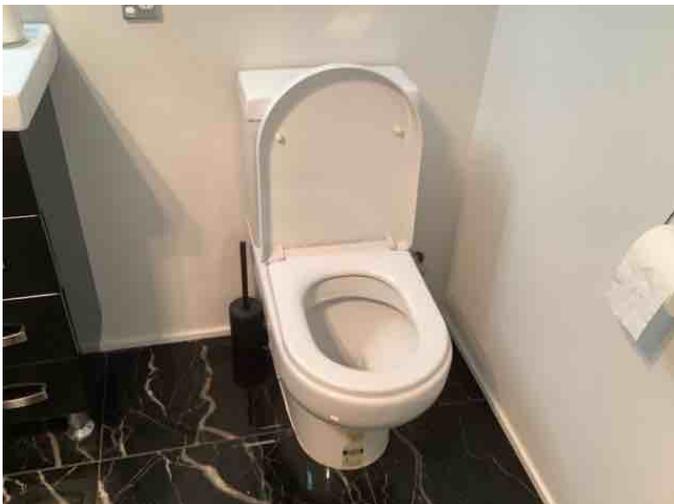
The toilet is well secured and in good working order.

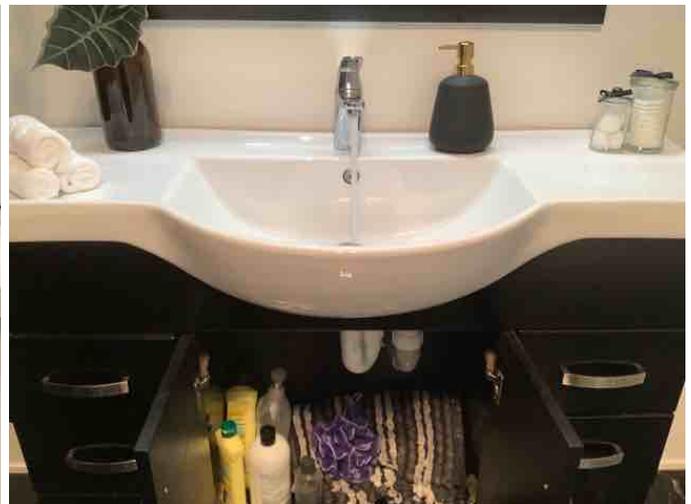
Recommend tightening the tap to the vanity. No concerns found with how it functions or the waste pipes below after testing it.

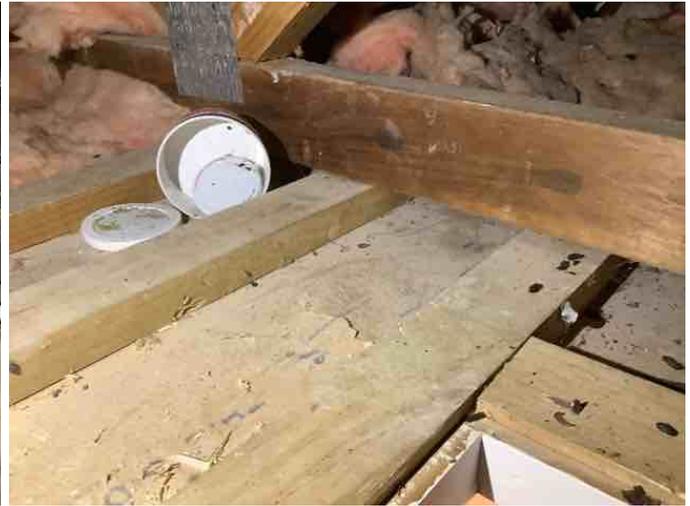
Vermin control measures are in place but more may be required if this is an ongoing problem.

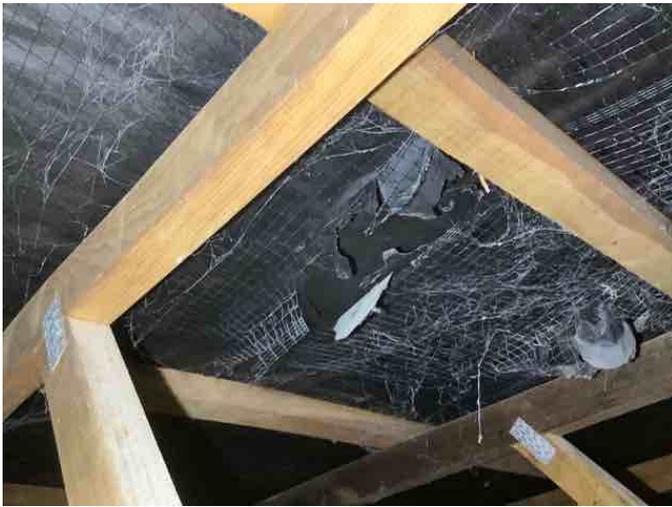
The roof paper was replaced with the recent roof upgrades. This is best practice.

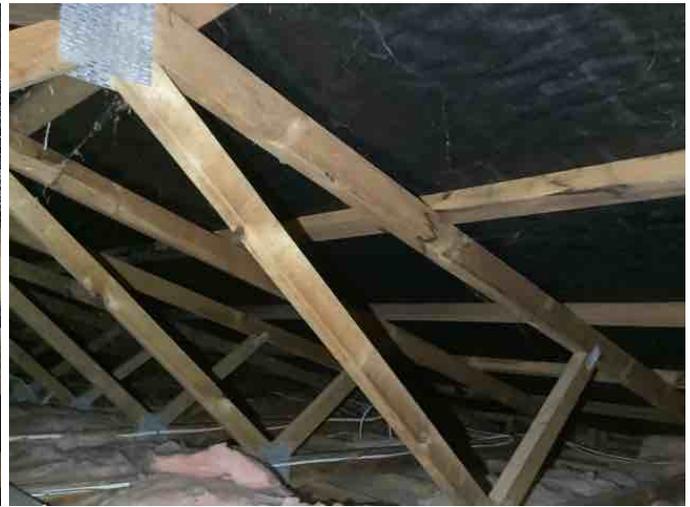
Historic moisture staining noted to several areas of the roof framing. Dry where checked with no structural concerns sighted. The roof has been replaced and it appears to be a past concern.

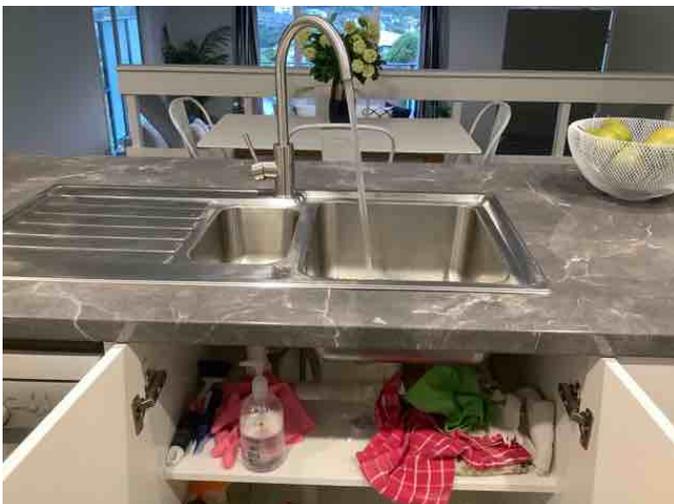
No visible concerns found with the tap or waste pipes below after testing it.

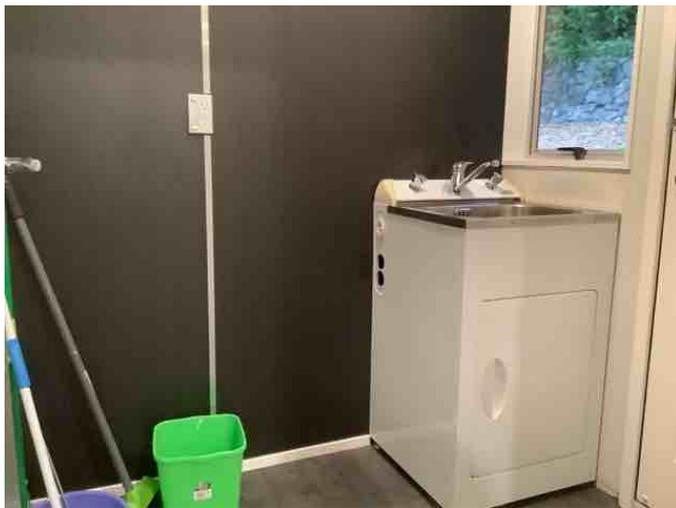
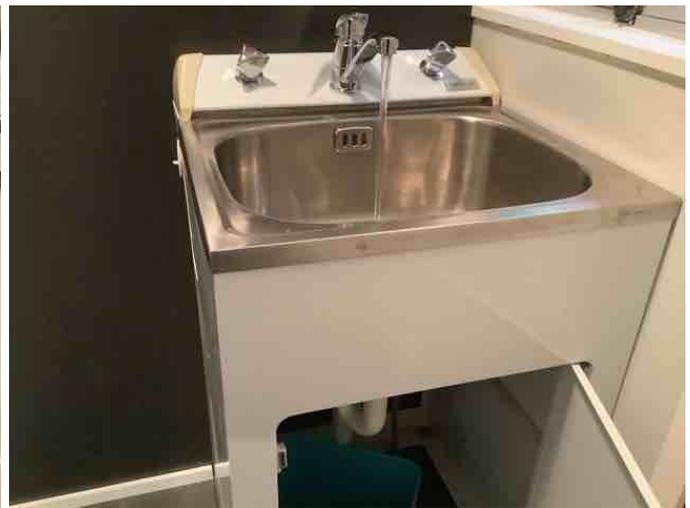
The tap is in good working order and no water related concerns are present with the plumbing pipes below after running it.

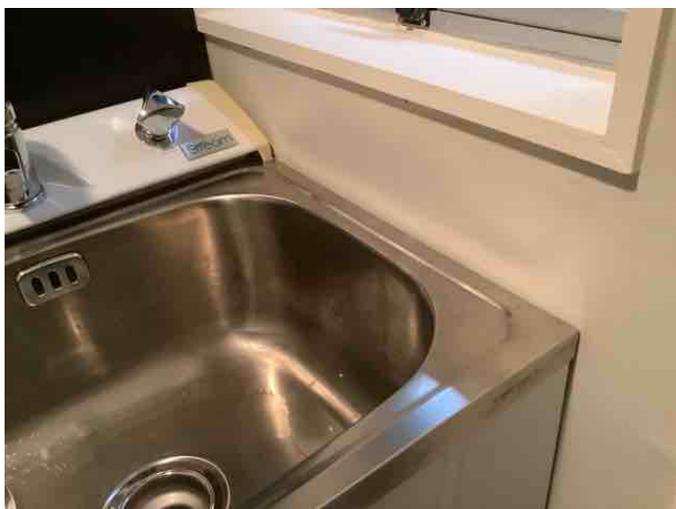
Recommend securing the tub in place and sealing the tub to wall junction with silicone to prevent moisture and debris getting behind.

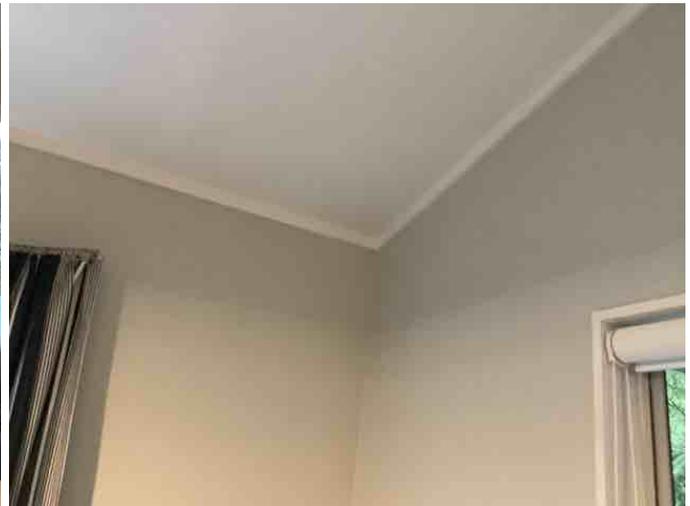
The entire interior has recently been decorated. This has been finished to a good standard.

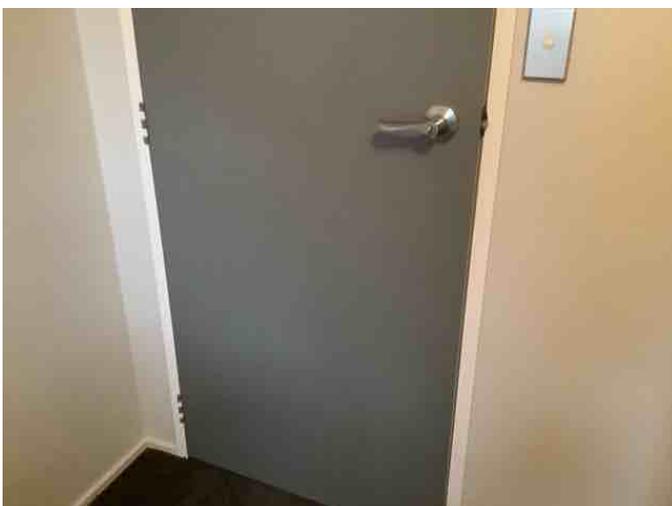
The bedroom door slightly binds when shut. Minor adjustments will improve this.

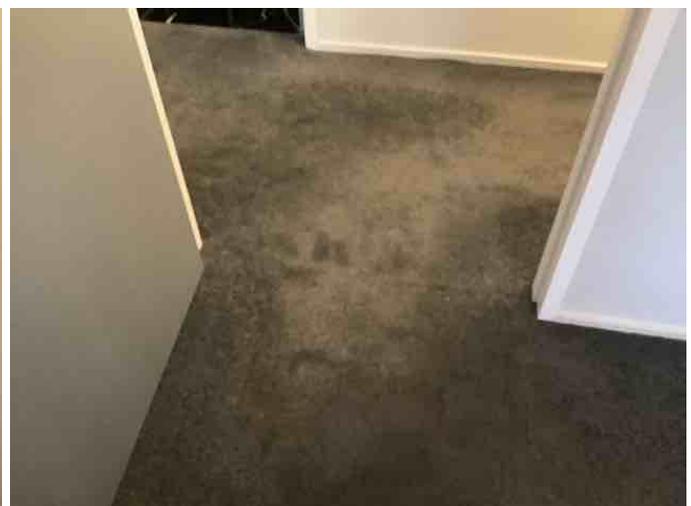
The homes carpet is in good order where able to view. Some of the internal doors rub on the carpet when in use but these can be eased where found to improve.

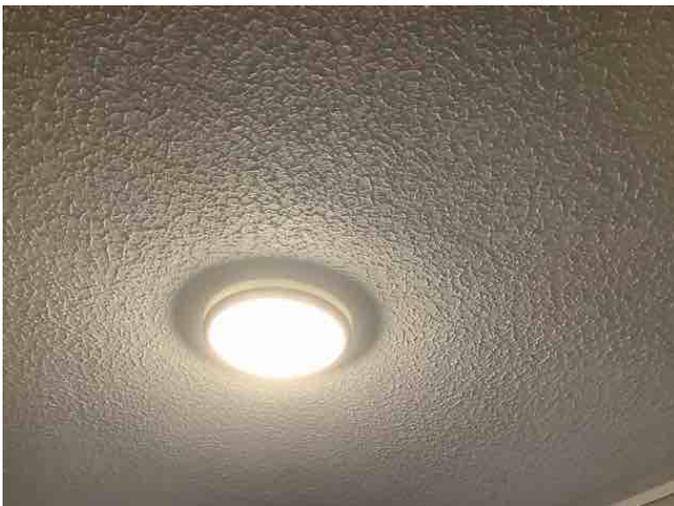
This is the only room in the home to have a textured plaster ceiling. This textured finish has the potential to have asbestos in its composition. This is of no concern if kept well sealed and in good order. There are no current areas where plaster is flaking or concerns are present. Samples should be sent for testing should removal be desired.

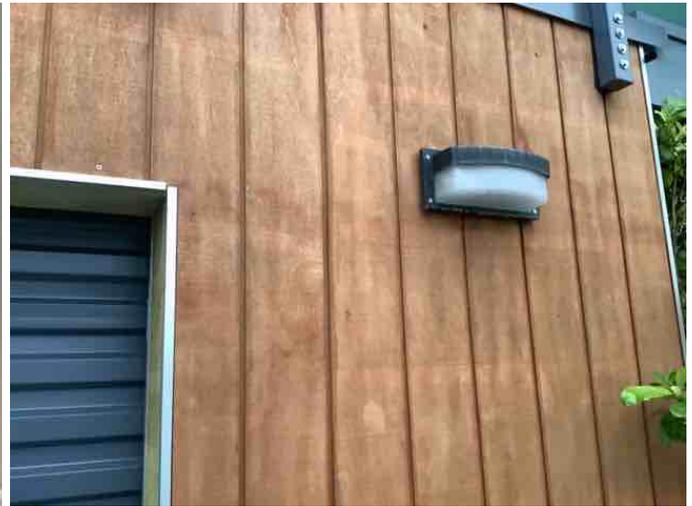
The front face of the garage has been re-clad in shadow clad or similar treated plywood type product. This requires additional fixings to be installed to make sure it is adequately secured to the framing behind. ¼ 150mm centres are recommended on it's perimeter and 300mm centres on the studs.
