SITE VISIT REPORT

Project Address:	40 Leighton Ave	Document Name:	224401-SN-001
Client:	Body Corporate 45792 C/- Oxygen	Building Consent:	N/A
Engager/Architect:	N/A	Builder:	N/A

DTCE went to the site to provide a visual assessment on the existing crack along the foundation of Unit A-D.

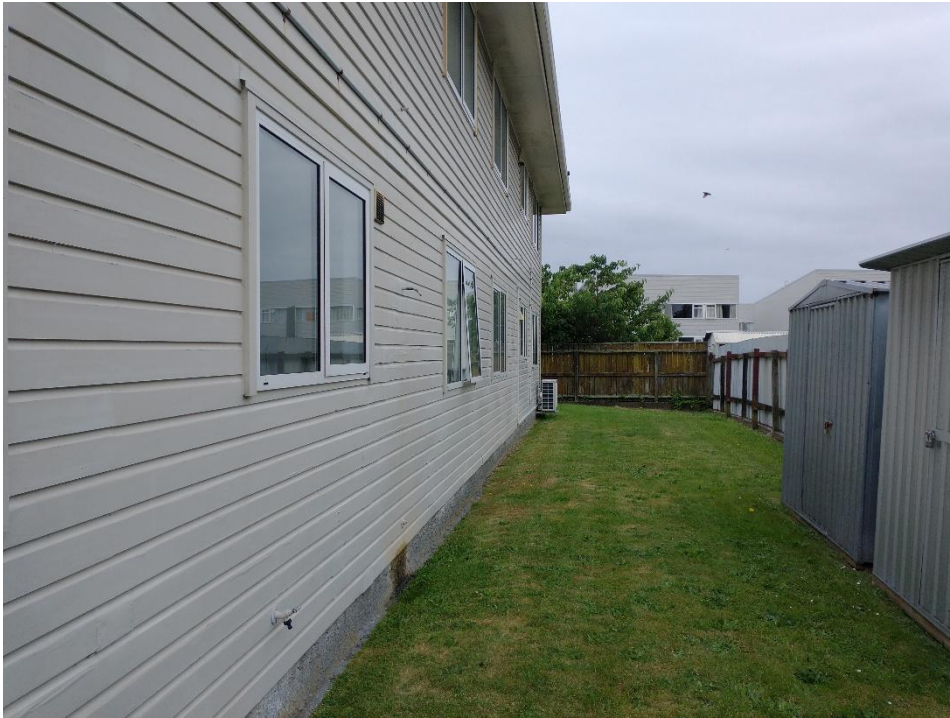
Figure 1.

Location: Northside overview of Unit A-D

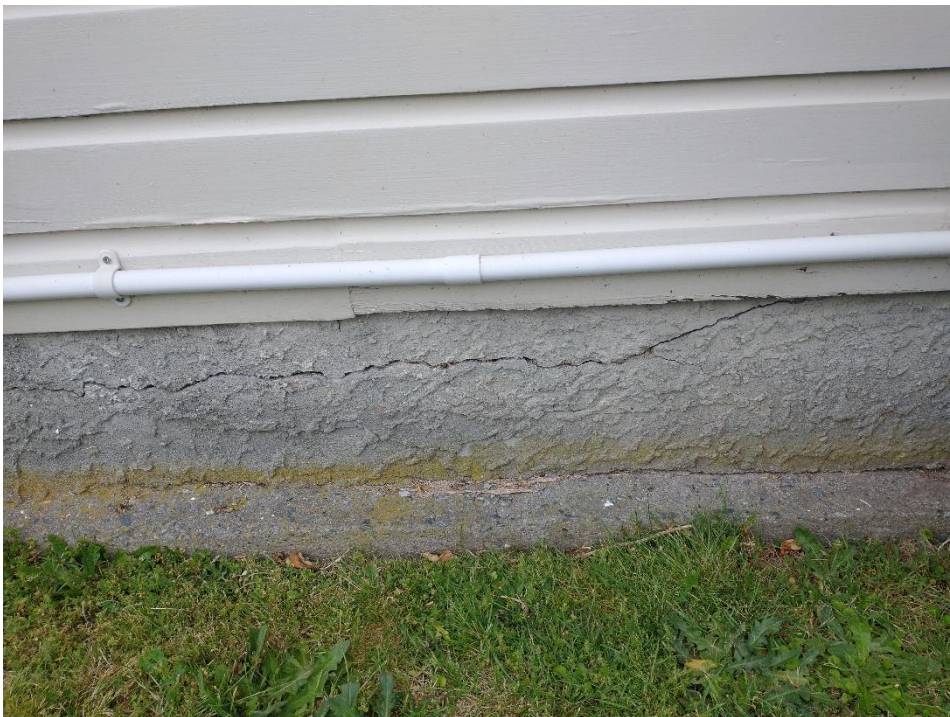
Figure 2.

Description: Horizontal cracks (approximately 8mm) were found along the external ring wall foundation.

Conclusion: The pattern of the cracks are consistent with the causes of corrosion. To confirm that the reinforcing has corroded, the reinforcing in the existing foundation should be exposed at the crack location. The reinforcement needs to be visual assessed. The absence of vertical (flexural) cracks indicates that the foundation is not settling or has a strength failure. Remedial works are likely required.

Description: Overview of the cracks along the ring wall foundation

Engage a builder to be exposed the reinforcing at the crack location. Once the condition of the reinforcing has been assessed, the remedial strategies can be developed.

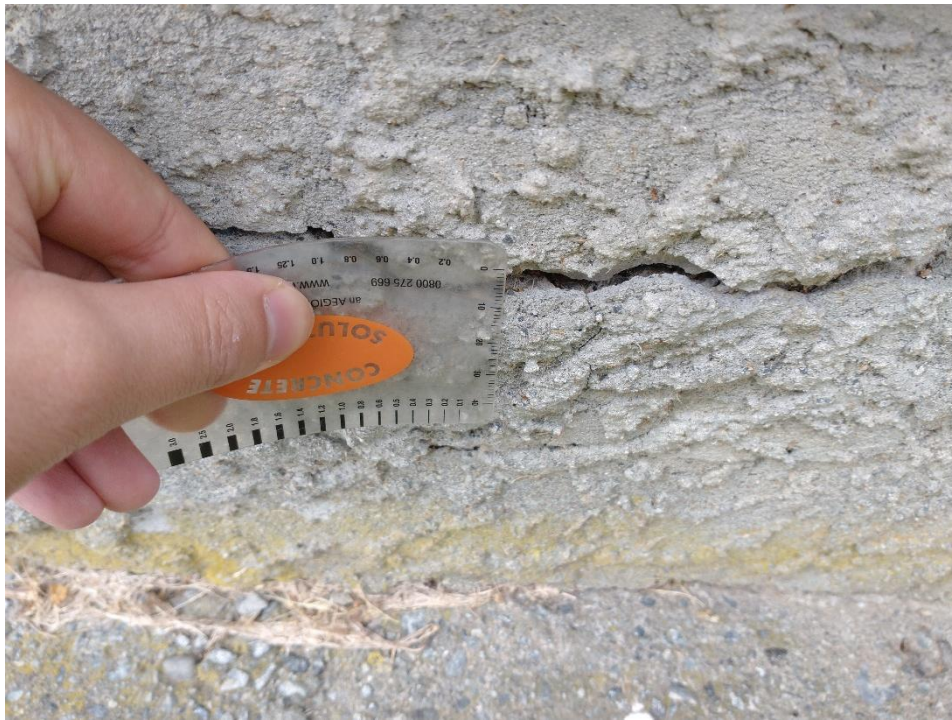
Figure 3.

Description: Closeup view of the crack

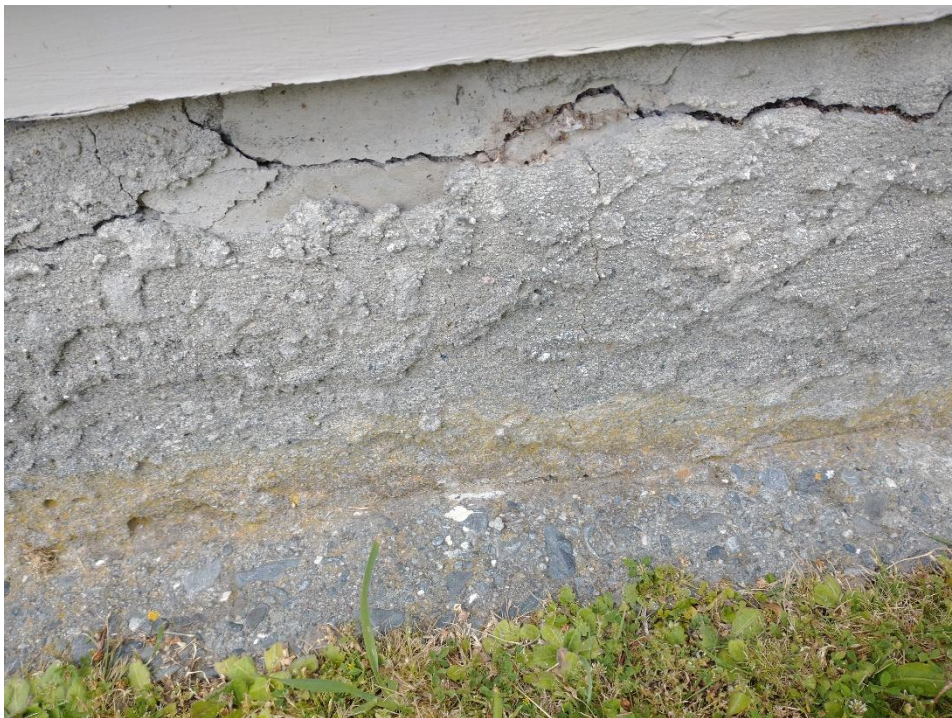
Figure 4.

Description: Closeup view of the crack

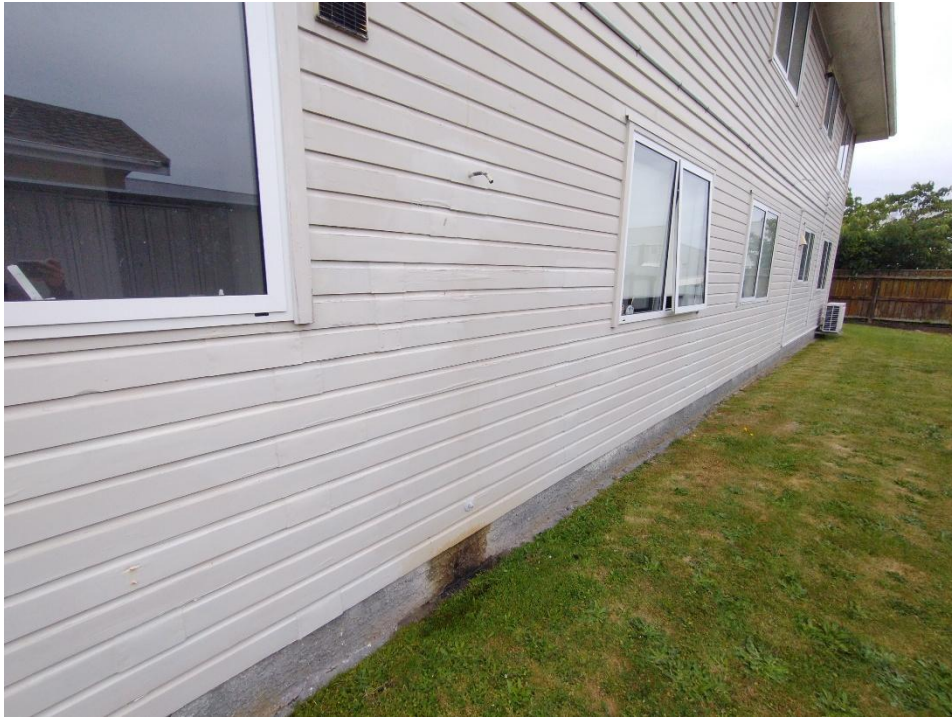
Figure 5.

Description: Drainage leaking at one location along the northside

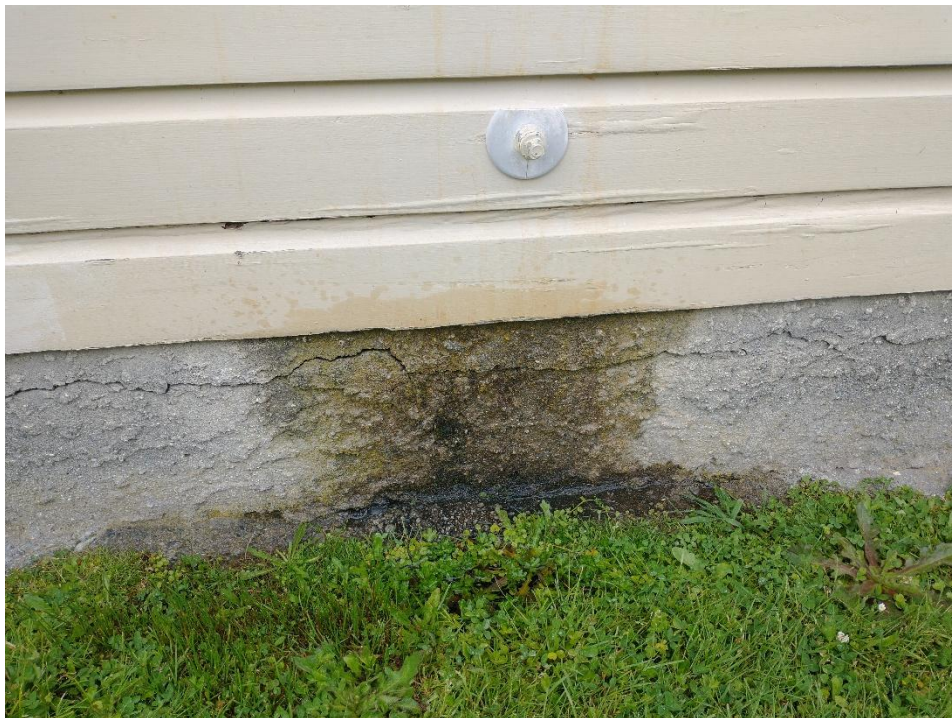
Figure 6.

Description: Drainage leaking at one location along the northside

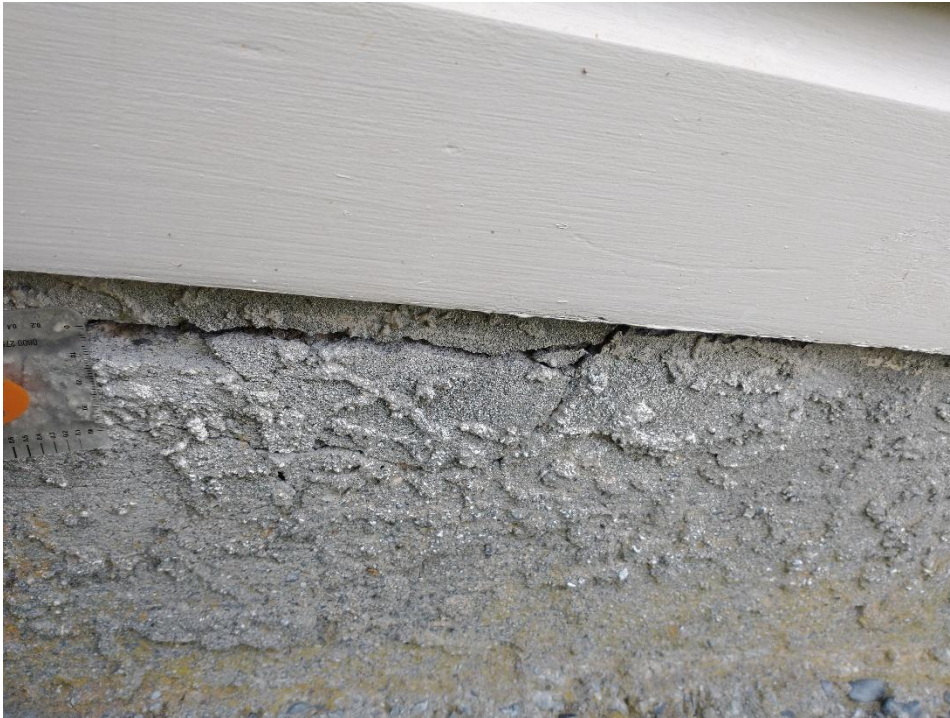
Figure 7.

Description: Closeup view of the crack
