GT Homes Ltd
76 Pererika Street

Geotechnical Assessment Report

March 2021

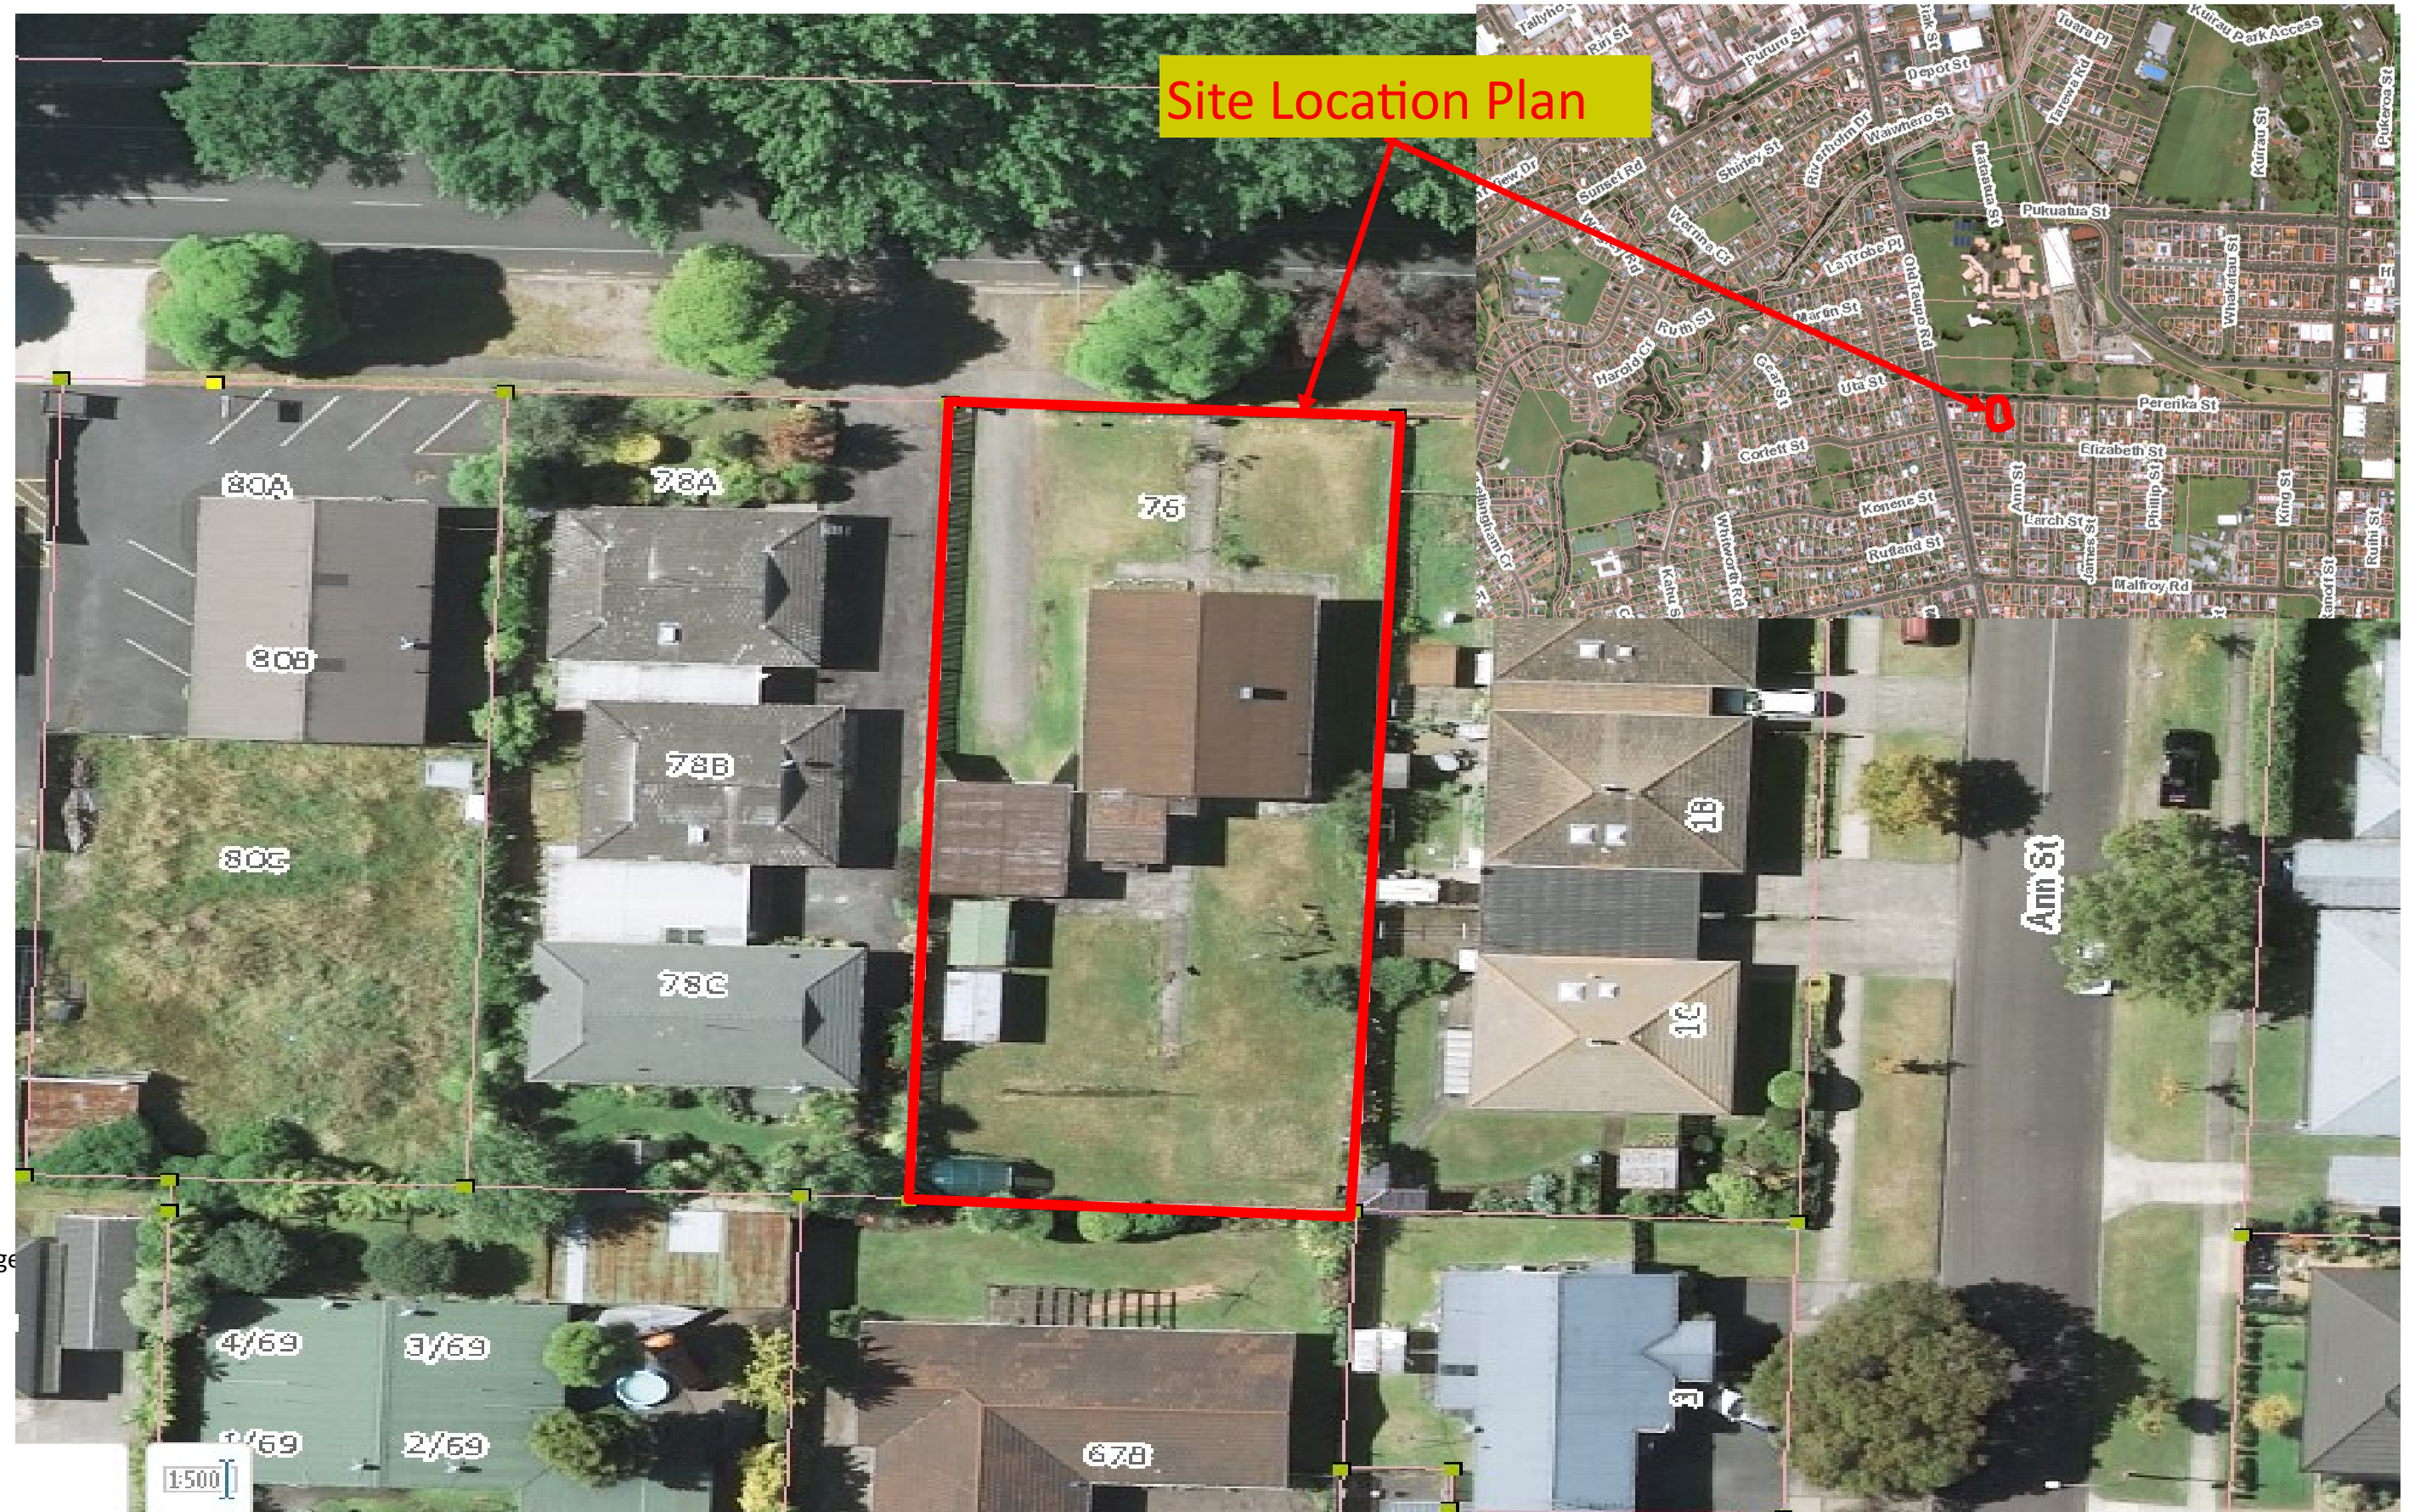
Site Location and Building Location Plan

We understand the development of the site will include subdivision into five lots and construction of one building comprising five double-storey lightweight timber framed townhouses. The proposed subdivision and building layout plan are presented in **Appendix A**.

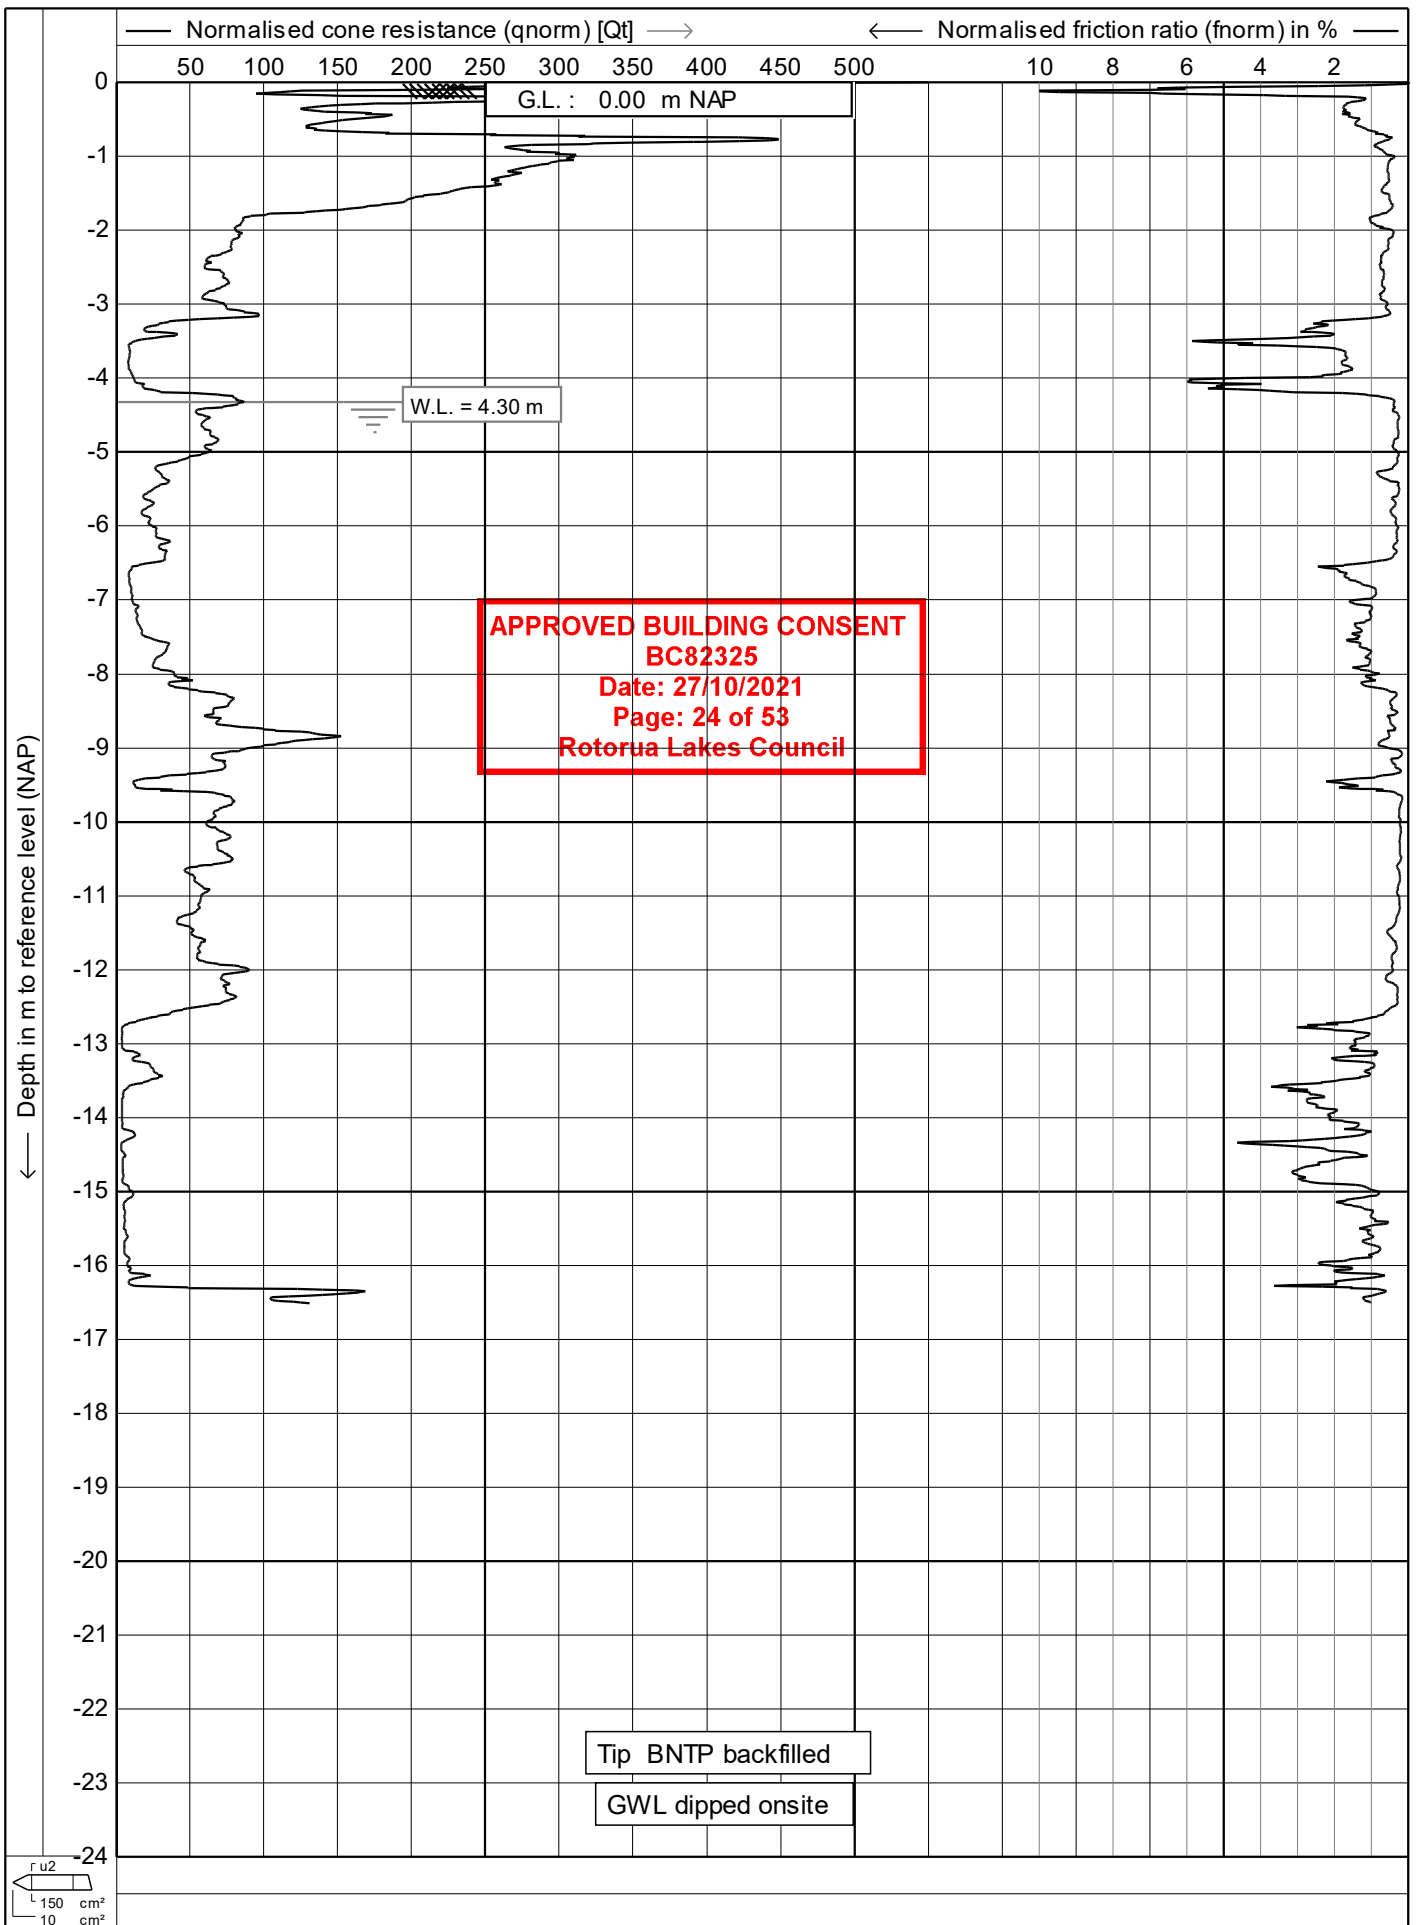
Test According A.S.T.M Standard D5778-12		Date : 21/01/2021	
	Project : Site Investigations		Cone no. : C10CFIPT.C18266	
	Location: 76 Pererika St - Rototua		Project no. : 03ST1	
	Position: 0, 0 RD		CPT no. : 03	
			8/15

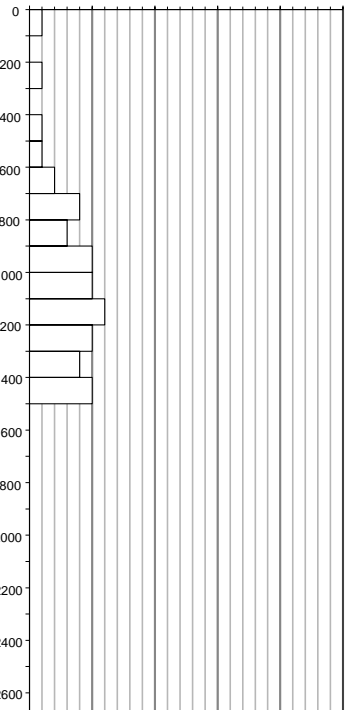
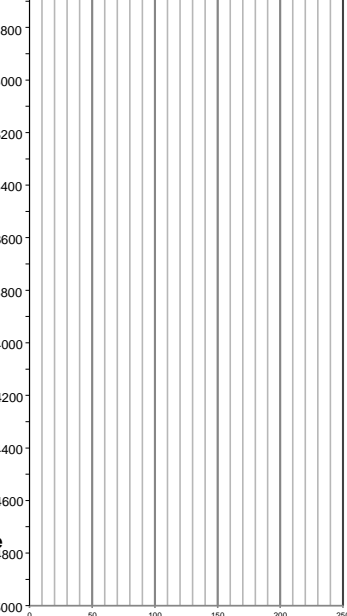
Associated Penetrometer No : SP11

Depth (m)	Groundwater	Graphic Log	DESCRIPTIONS	Strength	Soil Class(USCS)	Soil Strengths
0.0m		<div>⚡⚡⚡</div> <div>⚡⚡⚡</div> <div>⚡⚡⚡</div>	(TOPSOIL) SILT minor fine - medium sand, dark brown, dry - moist, low plasticity.		OL	<div>Soil Strengths</div> <div>□ Scala Penetrometer ◆ Shear Vane - Undisturbed ✕ Shear Vane - Remoulded</div> <div>SCALA PENETROMETER RESULTS</div> <div>Blows per 100mm</div> <div>

0.5m		<div>•••</div> <div>•••</div> <div>•••</div> <div>•••</div>	Fine SAND , light orangish brown, very loose - loose, moist, poorly graded.	VL	SP	
				L

1.0m		<div>•••</div> <div>•••</div> <div>•••</div> <div>•••</div>	SAND fine - medium, light yellowish brown, medium dense, moist, poorly graded.	MD	GP	
		<div>○°○°○°</div> <div>○°○°○°</div> <div>○°○°○°</div> <div>○°○°○°</div>	Fine pumiceous GRAVEL , light greyish brown, medium dense, moist, poorly graded.

1.5m		Target Depth				
2.0m						
2.5m						
3.0m						
3.5m						
4.0m						
4.5m						
5.0m						
Notes: Groundwater not encountered.						
Cohesive Material			Non Cohesive Material		Classification Symbols and Soil Description	
Very Soft VS Soft S Firm F Stiff St			Very Loose VL Loose L Medium Dense MD		Based on Field Description of Soil and Rock,	
Very Stiff Vst Hard H			Dense D Very Dense VD		New Zealand Geotechnical Society Inc, 2005.

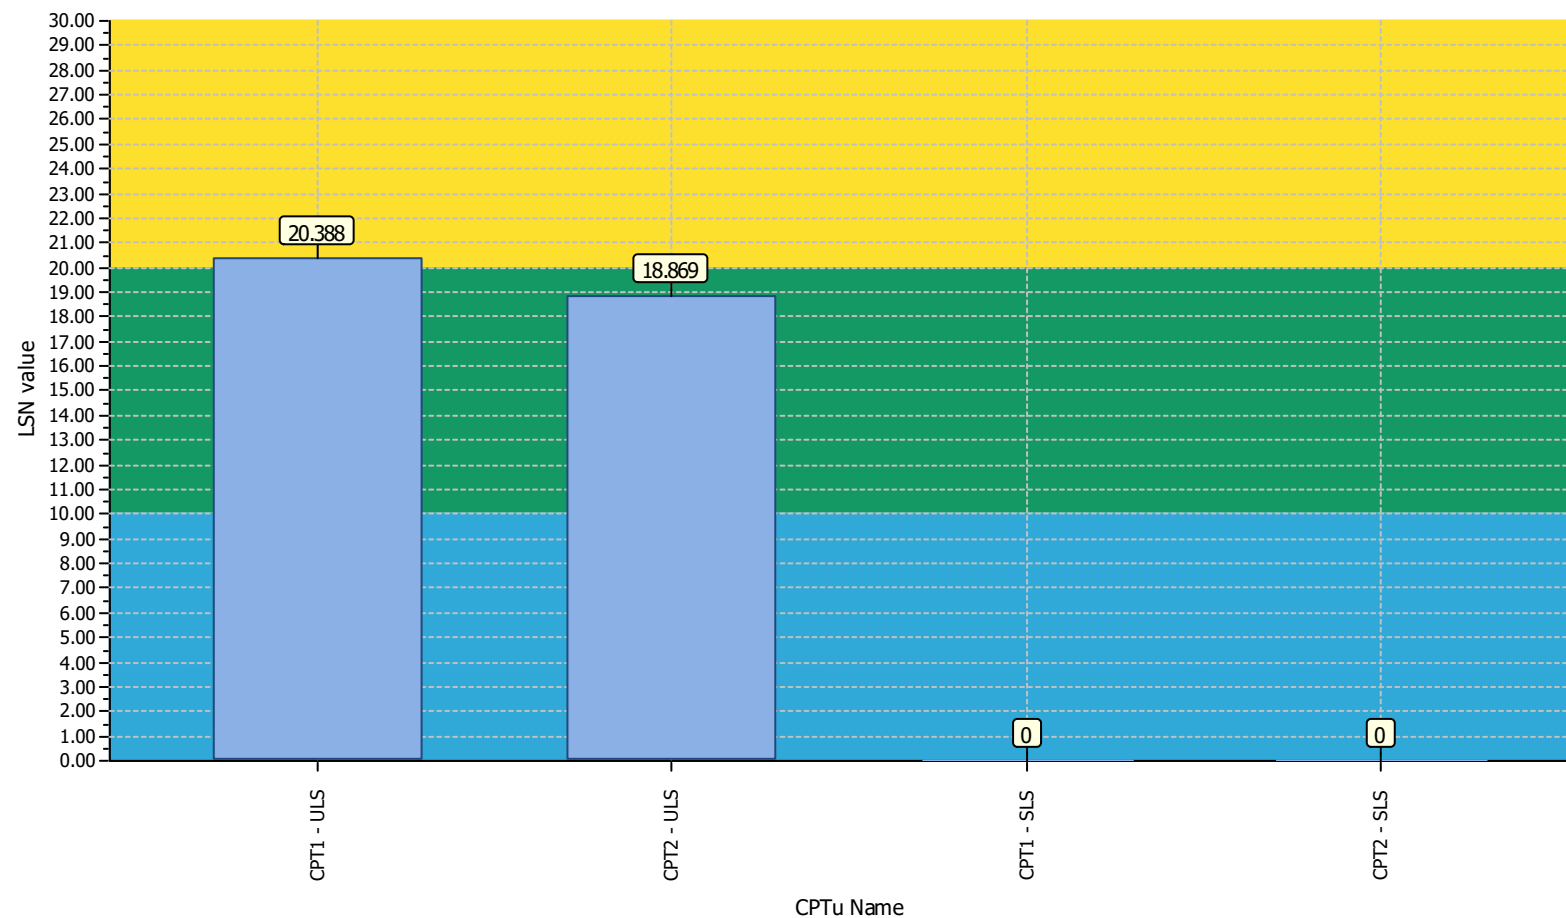
Overall Liquefaction Severity Number report

- Severe damage
- Major expression of liquefaction
- Moderate to severe exp. of liquefaction
- Moderate expression of liquefaction
- Minor expression of liquefaction
- Little to no expression of liquefaction
