# Your Building Inspection Report

CONFIDENTIAL REPORT FOR  
Joan Finley  
ID 157685  
Wednesday, October 29, 2025

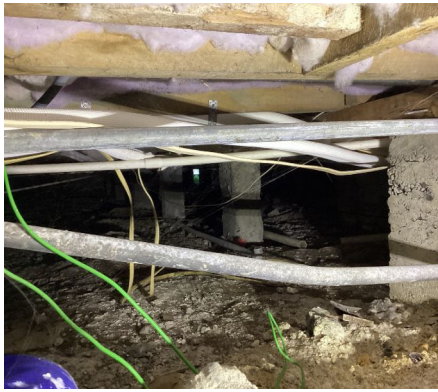
An area of the subfloor was not able to be inspected. This was due to low hanging pipes. This was due to low floor height.

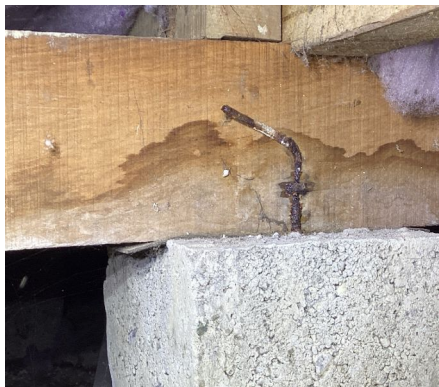
The piles to subfloor fixings have corroded. We recommend these are replaced.

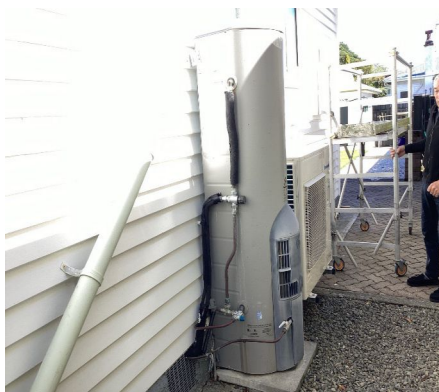
The average life span of this type of hotwater system is 10-12 years. This system is estimated to be older than this time frame. We suggest that a thorough examination is completed bi-annually (ideally at the end of winter and end of summer), and any pipe or cylinder breakdown, water pooling or any signs of deterioration should be investigated by a qualified plumber. No visible issues noted during the inspection.

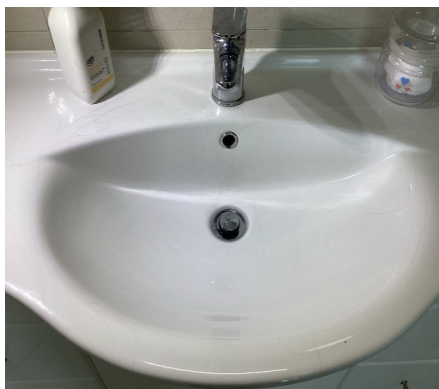
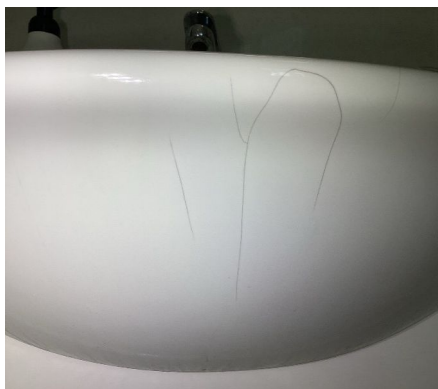
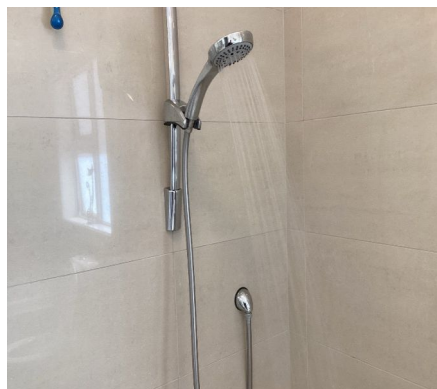
The basin is cracked. We recommend a new basin is installed by a registered plumber. The basin is still functional, so replacement may not be urgent.

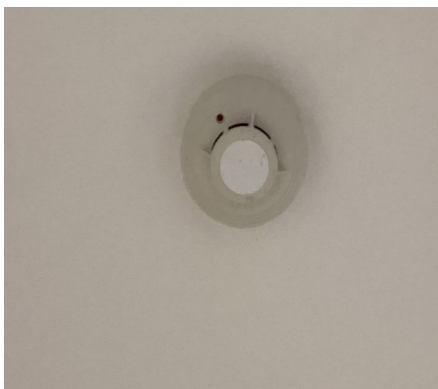
We recommend these are tested or replaced before moving into the property.
