## BUILDERS REPORT

### 4 Stormont Place | Kingston

# **House Inspection** **at** 4 Stormont Place Brooklyn

26-May-2025  
Ian Dumbleton

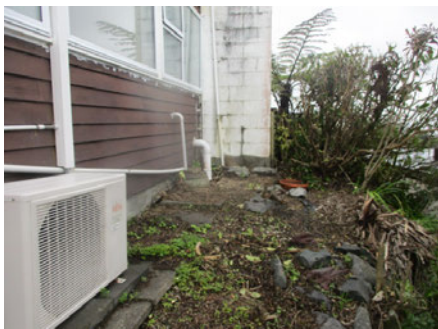
exterior heatpump unit

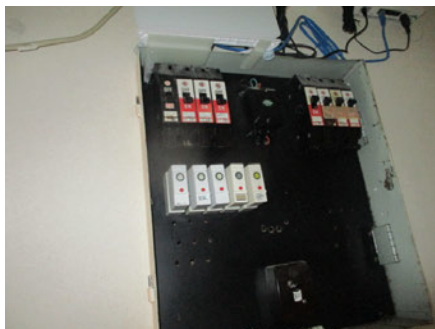
fuse board

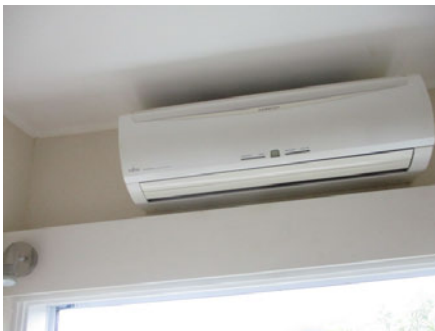
interior heating unit

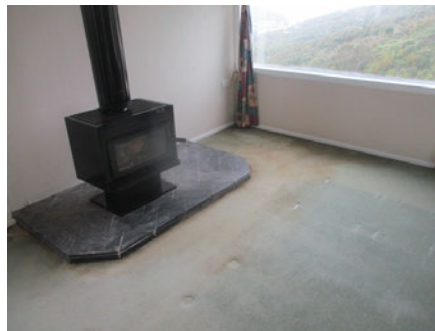
wood burner

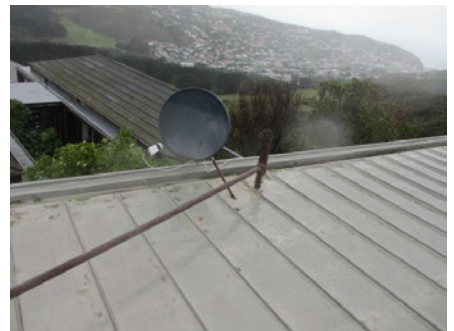
sky dish on roof

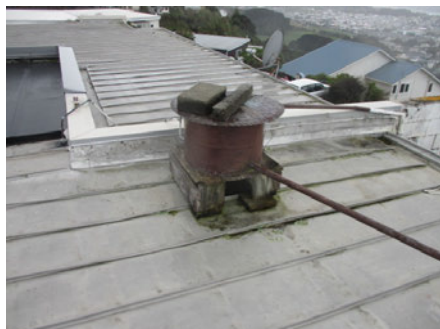
header tank on roof

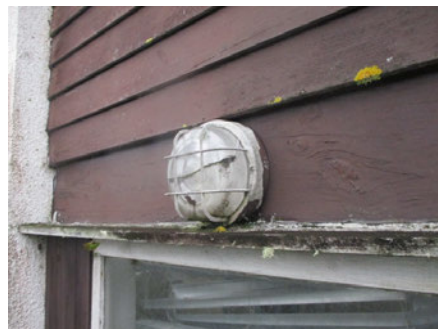
exterior lighting

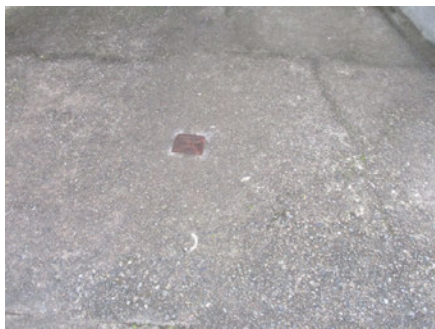
water toby in driveway

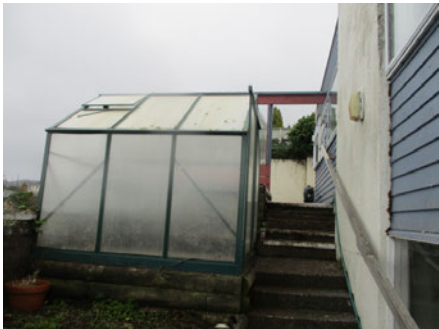
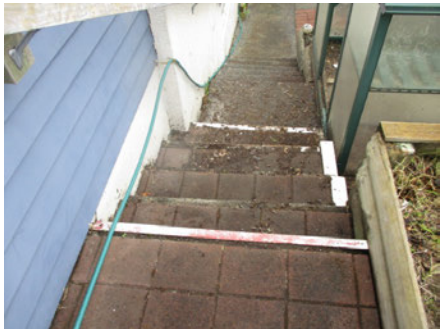
STAIRS - INTERNAL	TYPE	none
	CONDITION	
	COMMENTS	
HANDRAIL	CONDITION	
	COMMENTS	
STAIRS - EXTERNAL	TYPE	concrete
	CONDITION	average
	COMMENTS	some movement noted
HANDRAIL	yes	
	CONDITION	average
	COMMENTS	handrails only to some stairs

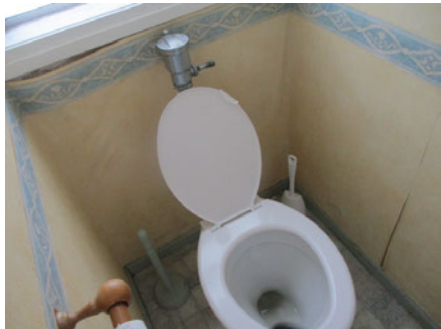
FLOORING	vinyl
WALLS	plasterboard wall paper peeling off
CEILINGS	plasterboard
DOORS	hollow core
WINDOWS	aluminium
TOILET	china single flush
TAPWEAR	n/a
VANITY TOP	No vanity
VANITY UNIT	no unit
MIRROR	No mirror

average

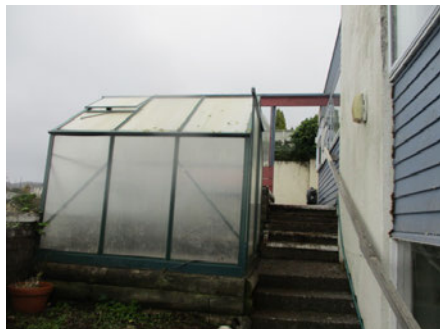
glass house

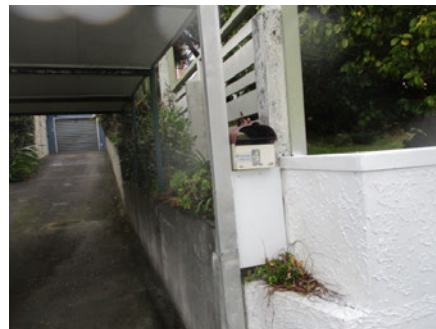
letterbox

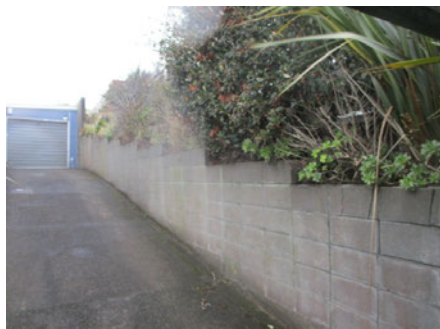
<b>RETAINING WALLS - CONCRETE</b>	CONSTRUCTION	concrete and crib blocks
	TYPE	
	CONDITION	good for age
	COMMENT	down driveway
<b>RETAINING WALLS - TIMBER</b>	CONSTRUCTION	not applicable
	TYPE	
	CONDITION	
	COMMENT

block wall

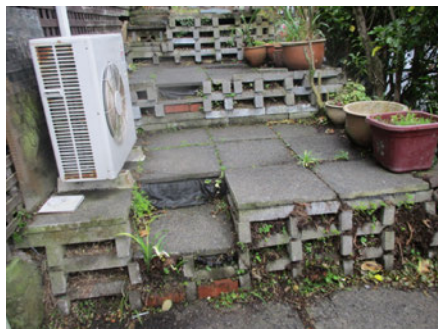
crib block walls

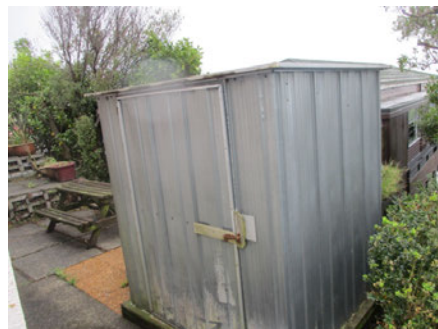
garden shed

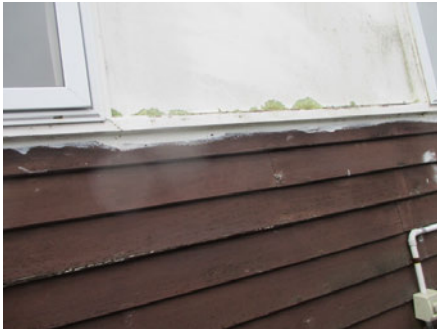
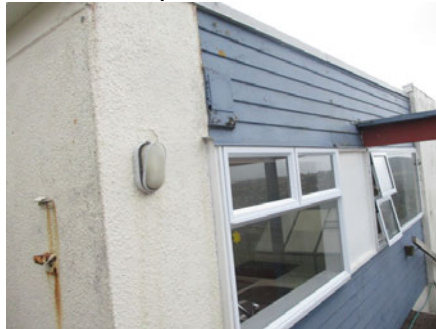
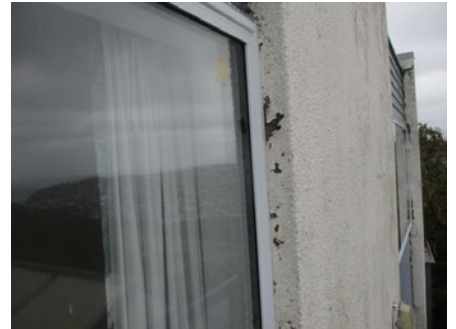
## EXTERNAL STRUCTURE & CLADDING

<b>WALL STRUCTURE</b>	TYPE	timber framed
	CONDITION	average
	COMMENT	generally in good condition
<b>BASEMENT</b>	TYPE	weather boarded and cement board
	FINISH	paint finish
	CONDITION	average
<b>WALL CLADDING</b>	COMMENT	needs repaint
	TYPE	weatherboard and cement board
	FINISH	paint
	CONDITION	average
	COMMENT	needs repaint

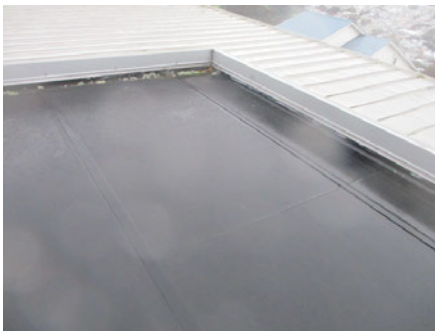
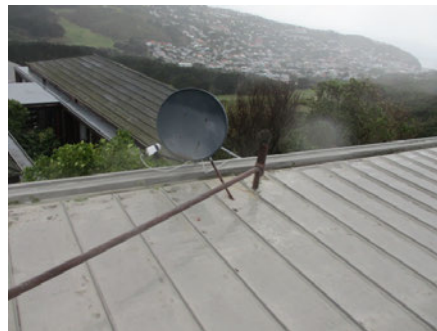
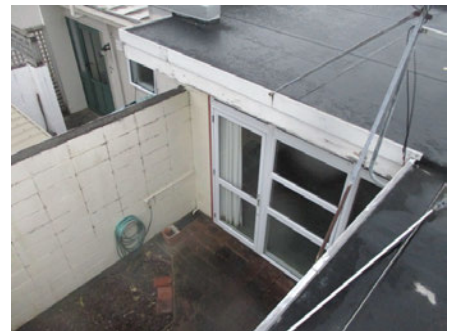
## EXTERNAL STRUCTURE & CLADDING CONTINUED

<b>ROOF</b>	TYPE	Butynol type roof membrane and aluminium
	FINISH	painted
	CONDITION	average
	INSPECTED	by getting on to
<b>SOFFIT</b>	COMMENT	needs repainting
	TYPE	cementboard
	FINISH	painted
	CONDITION	need maintenance
<b>FASCIA</b>	COMMENT	needs repaint
	TYPE	timber
<b>FLASHINGS</b>	CONDITION	needs painting
	TYPE	aluminium flashings
	CONDITION	generally good
<b>SPOUTING</b>	COMMENT	no comment
	TYPE	metal painted
	CONDITION	generally good
<b>CHIMNEY</b>	COMMENT	no comment
	TYPE	steel flue
<b>TV AERIAL</b>	COMMENT	HAVE CLEANED AND CHECKED BEFORE USE
	yes	
	COMMENT	sky dish noted and standard TV aerial

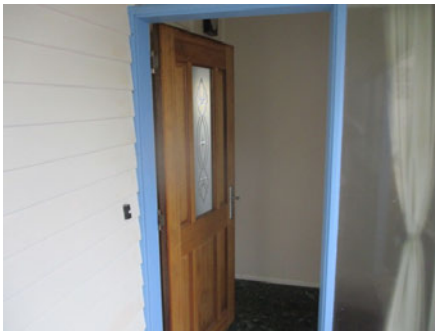
front door

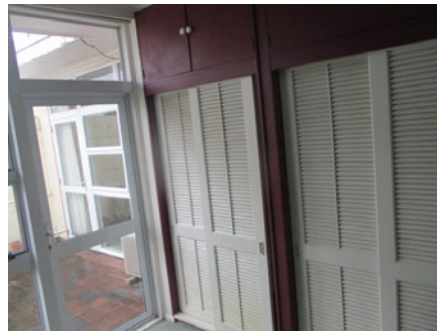
exterior door

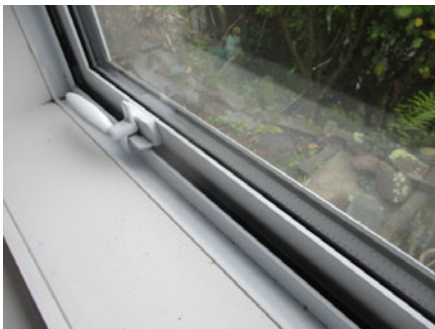
some windows double glazed

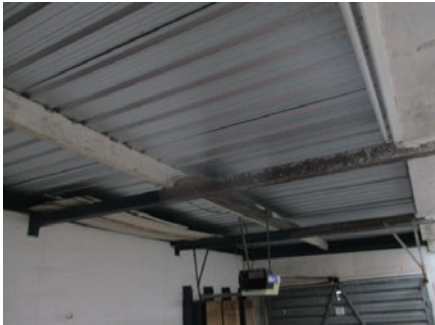
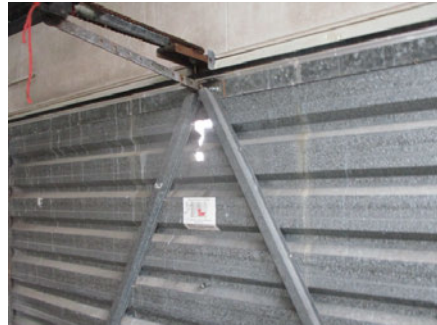
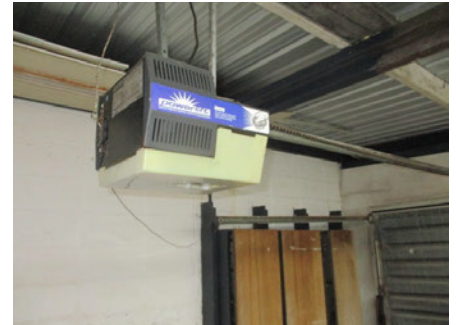
## GARAGE

<b>GENERAL</b>	TYPE	part of house
	CONDITION	average
	COMMENT	door opener needs repairs
<b>DOOR</b>	TYPE	auto
	CONDITION	tilta door
	COMMENT	needs fixing
<b>POWER SUPPLY</b>	TYPE	yes
	CONDITION	yes
	COMMENT	concrete
<b>LIGHTING</b>	TYPE	generally good
	CONDITION	
<b>FLOOR</b>	TYPE	
	CONDITION
