Independent Builders Report

THIS Southern Manawatu Ltd

Tue 16 Mar 2021

6 Swadel Way, Karori, Wellington, 6012, New Zealand

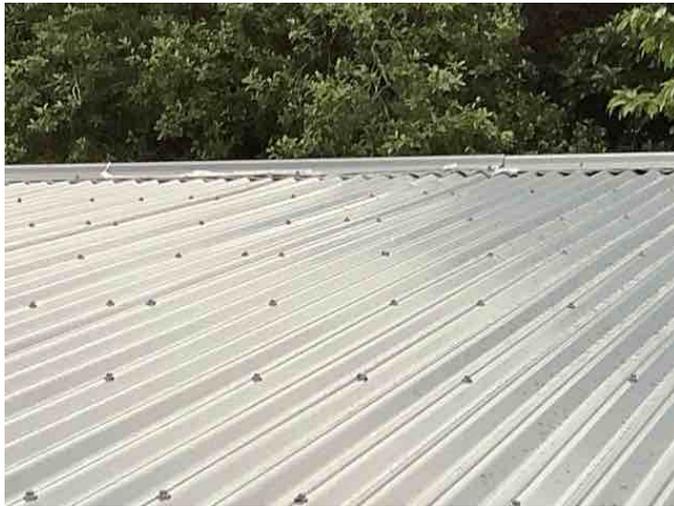
It appears that the plastic cover is yet to be removed from the ridge cap.

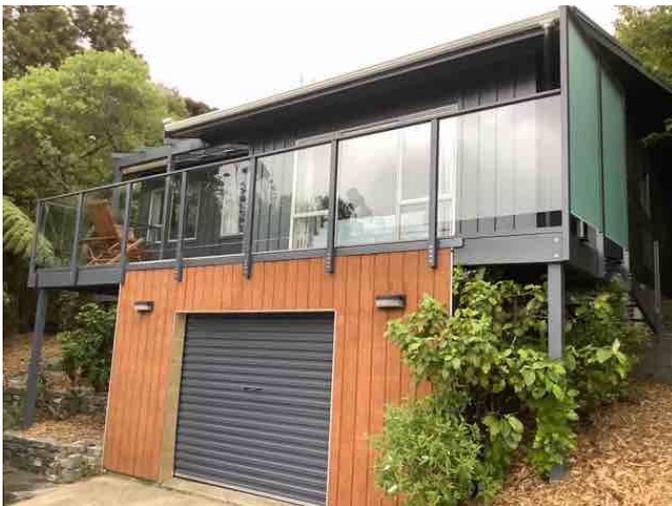
For further reference within the report, the front of the home faces the drive.

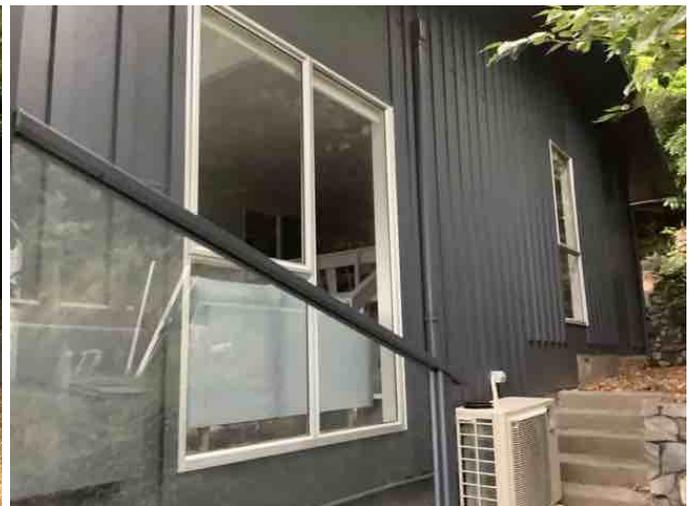
The right face.

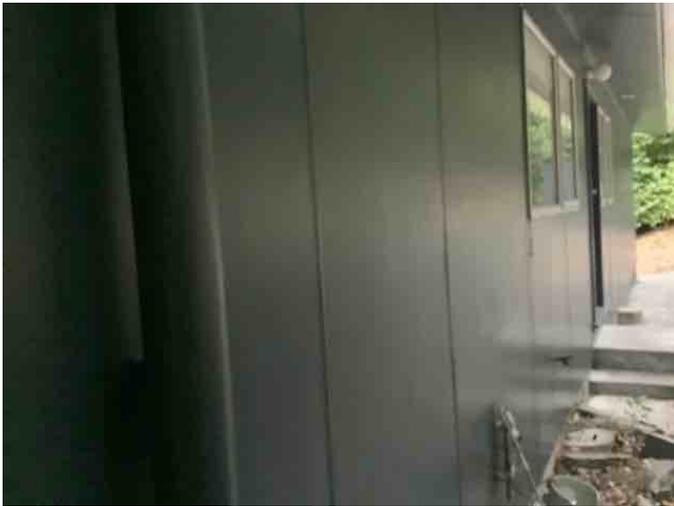
The rear of the home.

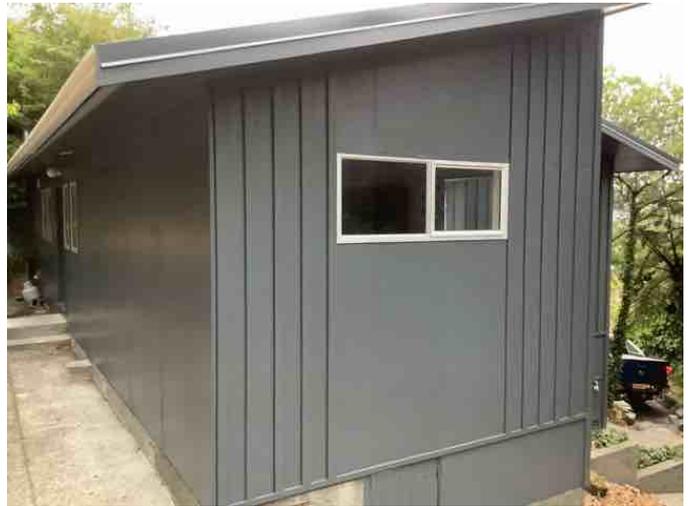
The left face.

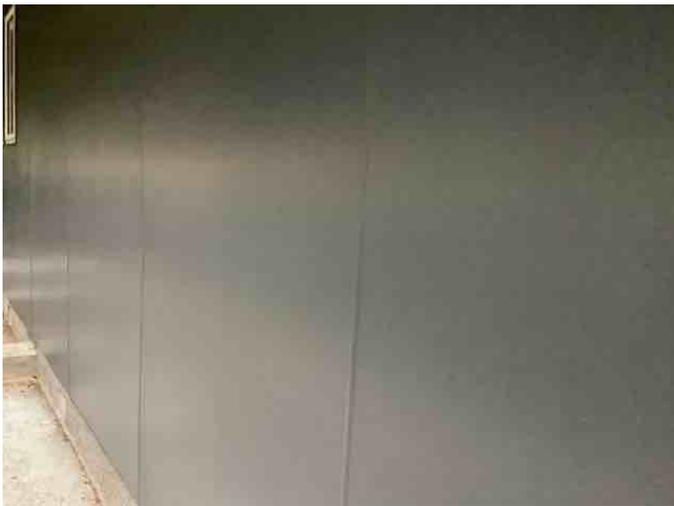
The cement sheet cladding looks to be well sealed with the recent paint and in good order. Giving the homes exterior an annual soft wash with a moss and mould killer will help to preserve the paint seal.

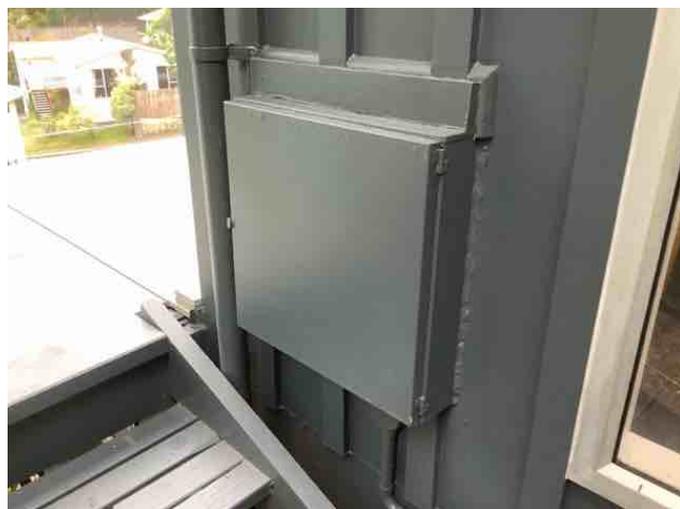
The meter board is well detailed and sealed to the cement cladding.

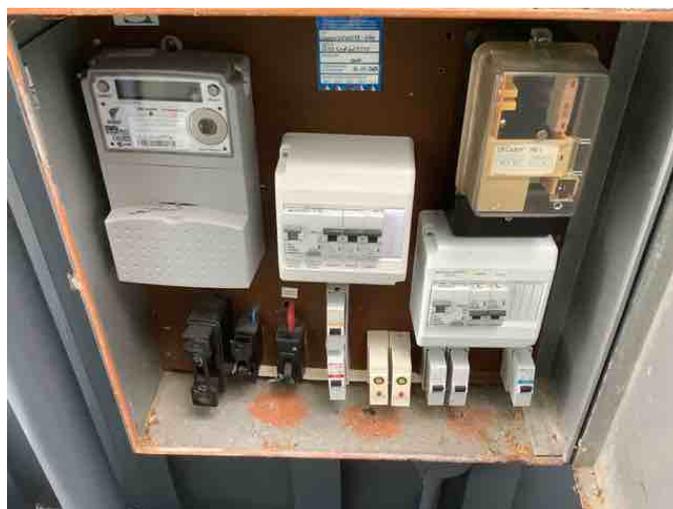
The homes fuse board has been fully upgraded to circuit breakers. No visible concerns with all circuits turned on.

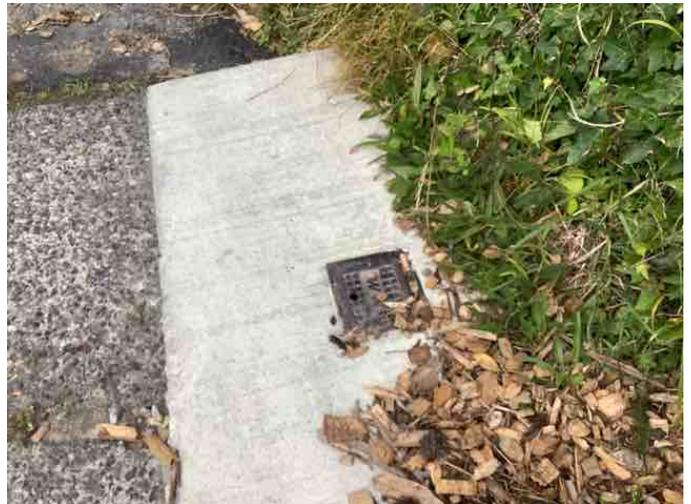
The homes water isolation valve is located at the front of the property.

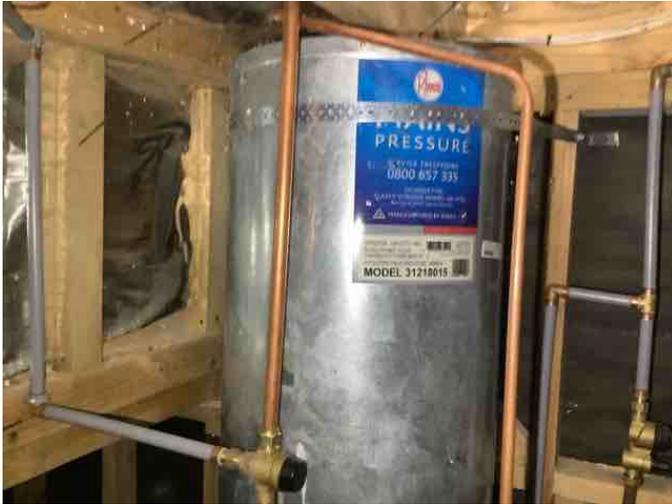
180L Mains pressure cylinder with a seismic restraint fitted.

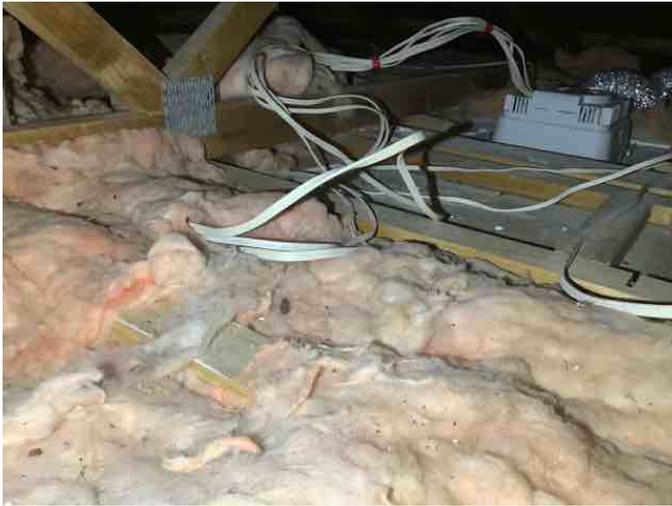
Majority of the the ceiling cavity is insulated with the thinner old type. In filling the gaps before installing insulation over the top will improve the homes heat retention.

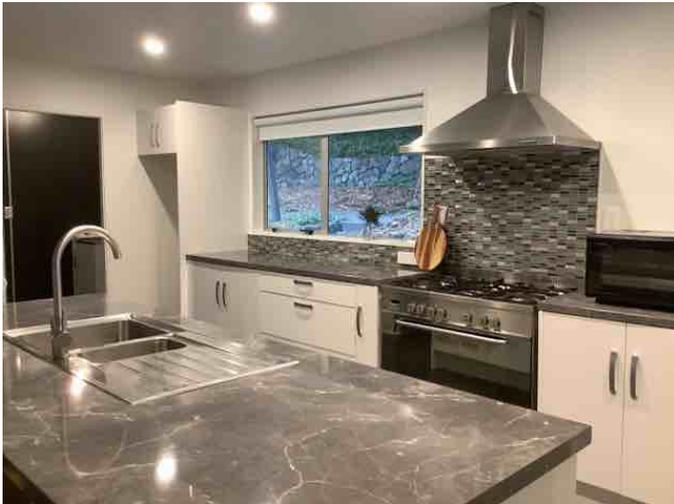
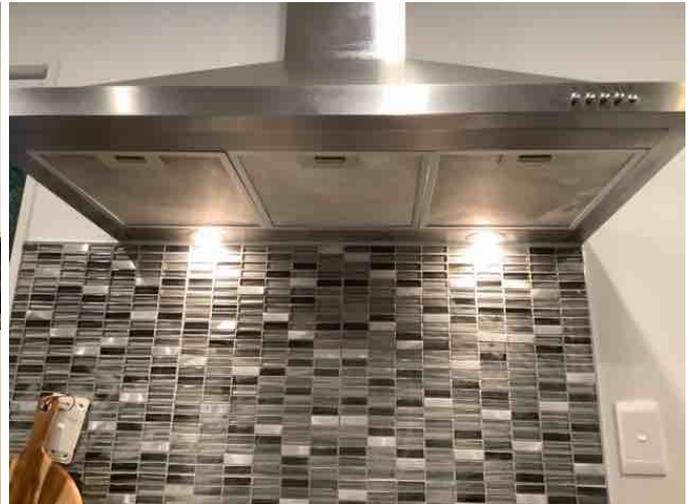
The extractor is in good working order.

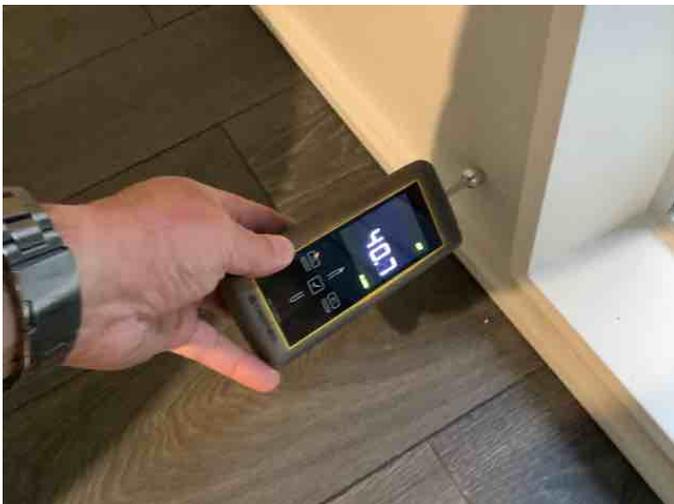
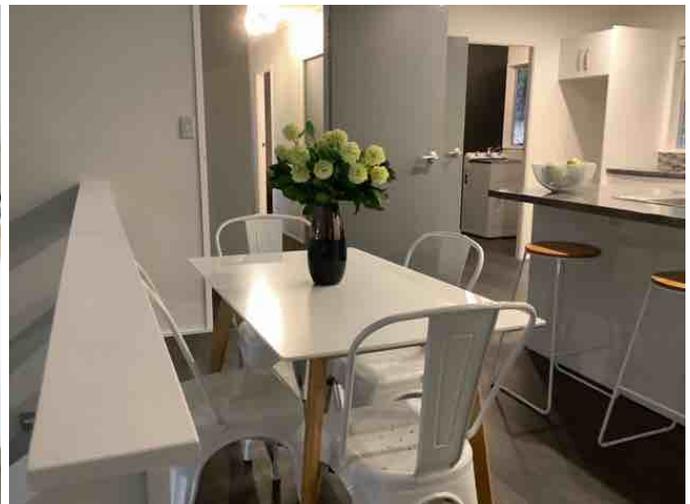
Dining room.

No elevated moisture readings detected from the rooms external walls.

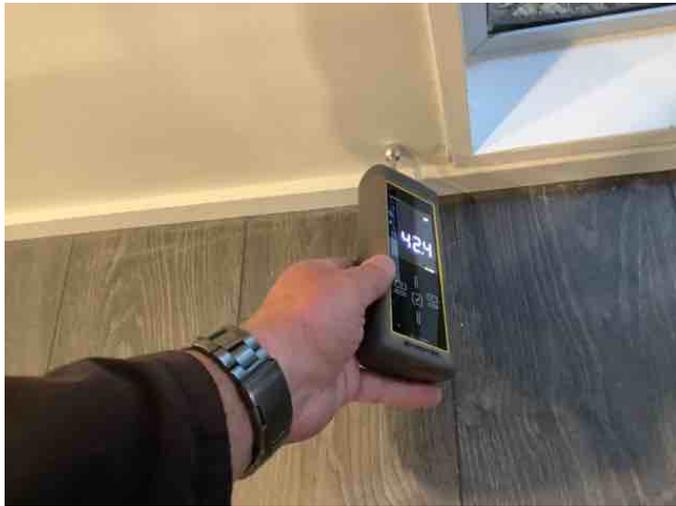
No elevated moisture readings detected from the rooms external wall.

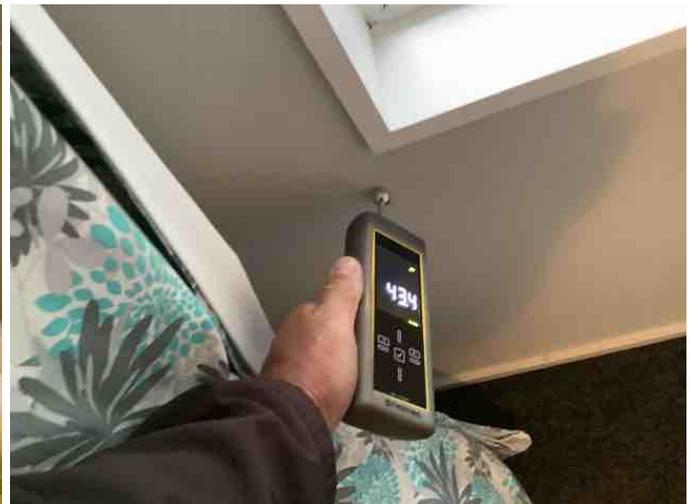
No elevated moisture readings detected from the rooms external wall.

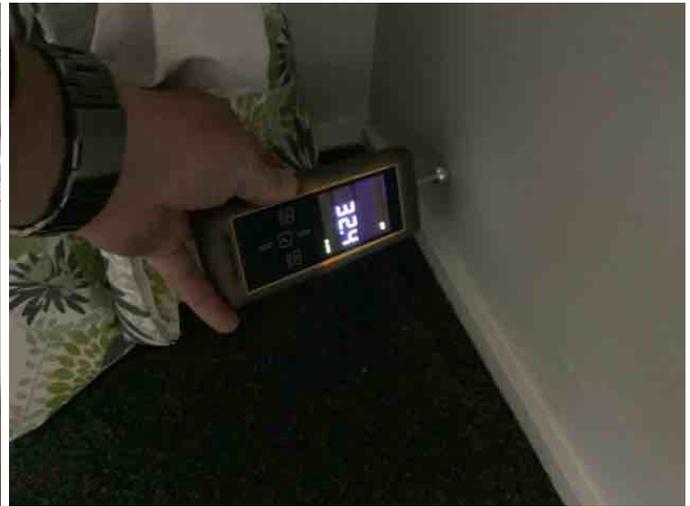
No elevated moisture readings detected from the rooms external walls.

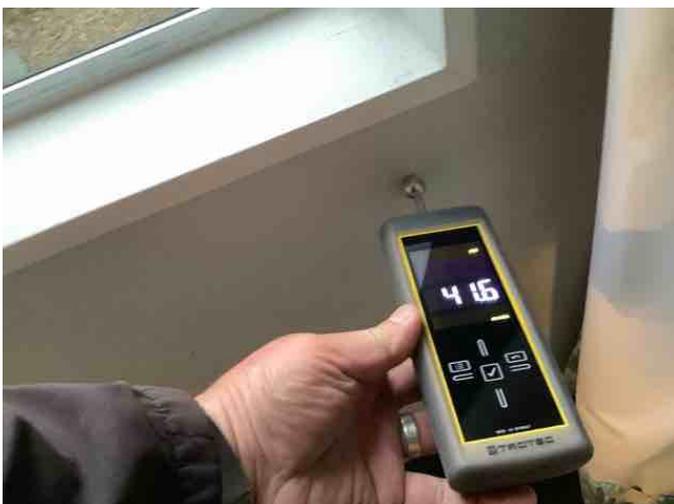
No elevated moisture readings detected from the accessible areas of the rooms external walls.

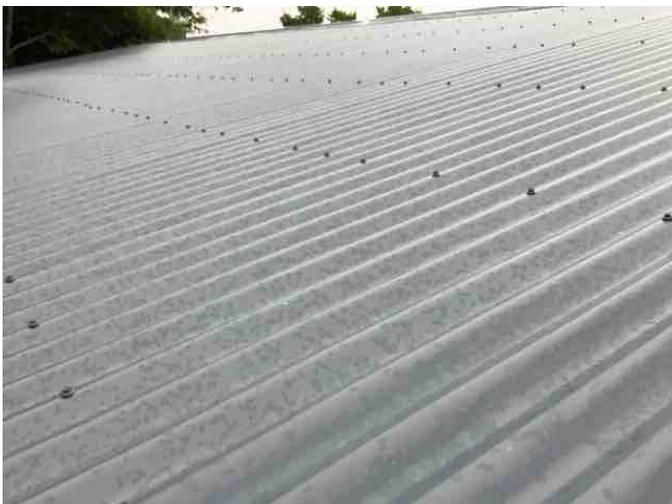
The roof wasn't accessed due to the moisture present after the recent rain. It was viewed by ladder at the rear and front. It has been fully replaced in recent years and although appearing to be in good order, minor improvements are needed.

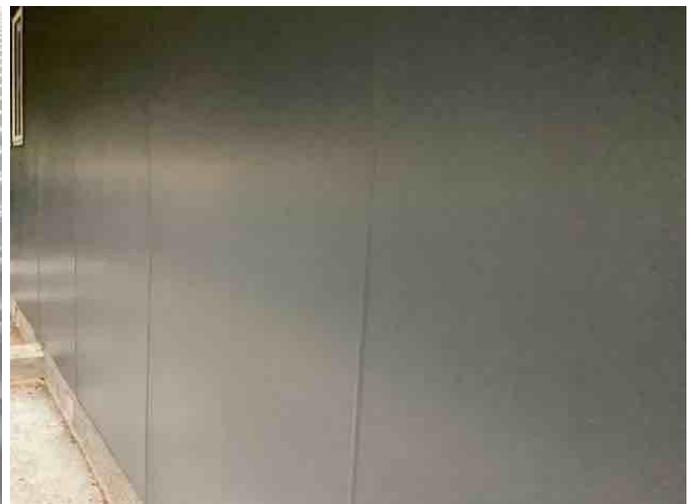
The cement sheet cladding looks to be well sealed with the recent paint and in good order. Giving the homes exterior an annual soft wash with a moss and mould killer will help to preserve the paint seal.

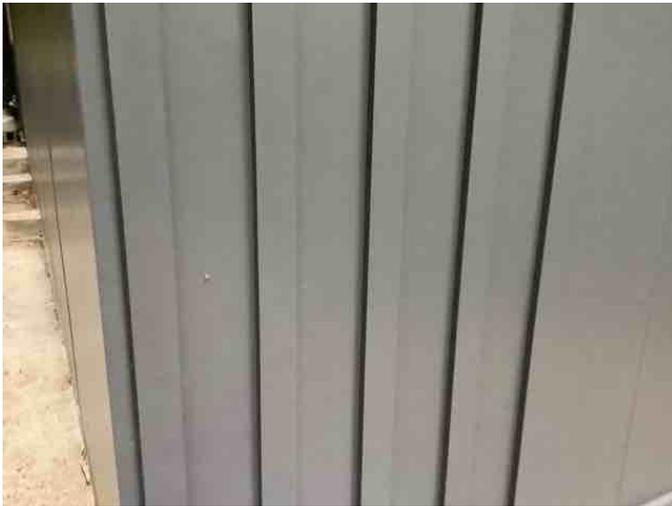
The board and batten clad areas appear to be in similar condition with no concerns sighted.

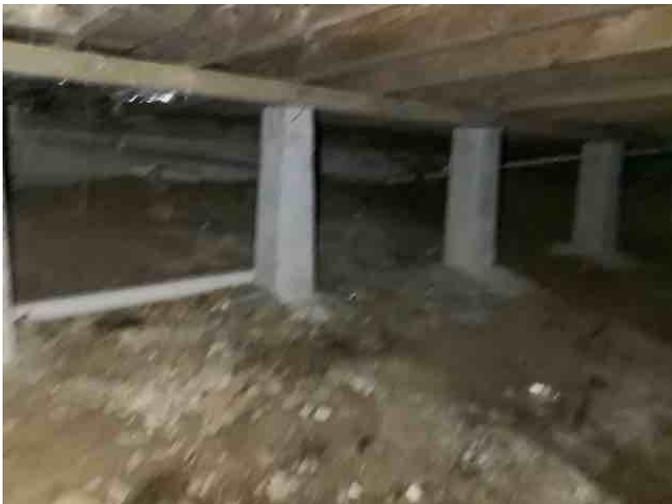
Good ground clearance is present below the framing for ventilation with no structural concerns sighted.
